**FRAMEWORK SERVICE CONTRACT FOR
COPERNICUS "EMERGENCY MANAGEMENT
SERVICE - RISK AND RECOVERY MAPPING"**

**EMSN-050:
Post Mathew Damage Assessment and Monitoring
of Recovery Activities in the South Region of Haiti
FINAL REPORT**

August 2018

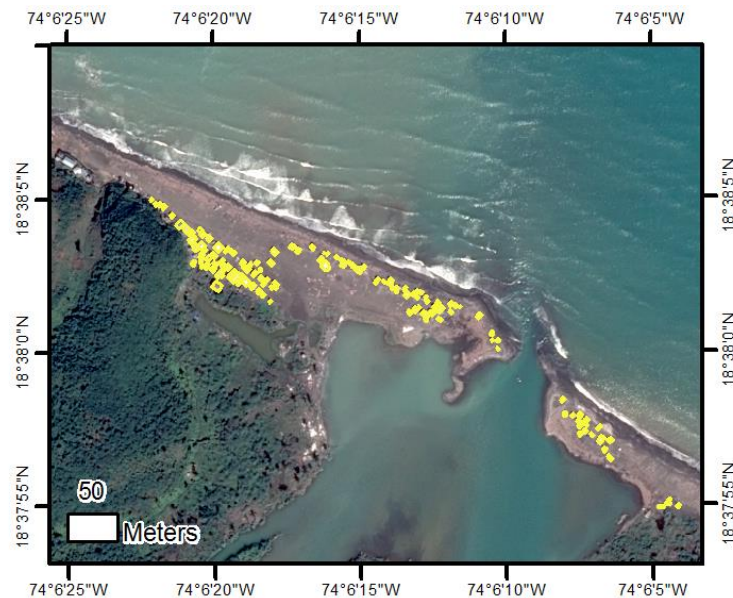
Figure 2-3: Putative IDP settlement on beach east of Jérémie. Shown is t3.

Further concentrations of assumed IDP dwellings are found along the beach east of Jérémie (previous figure) and east of Vieux Bourg de Jérémie.

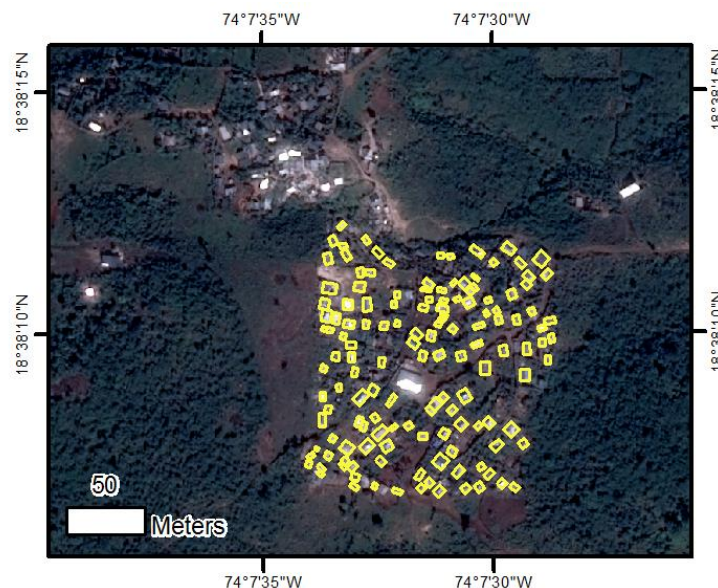
Figure 2-4: Potential IDP settlement southwest of Jérémie. Shown is t3.

One larger potential IDP settlement is located approximately 2 km south-west of the town center of Jérémie (next figure).

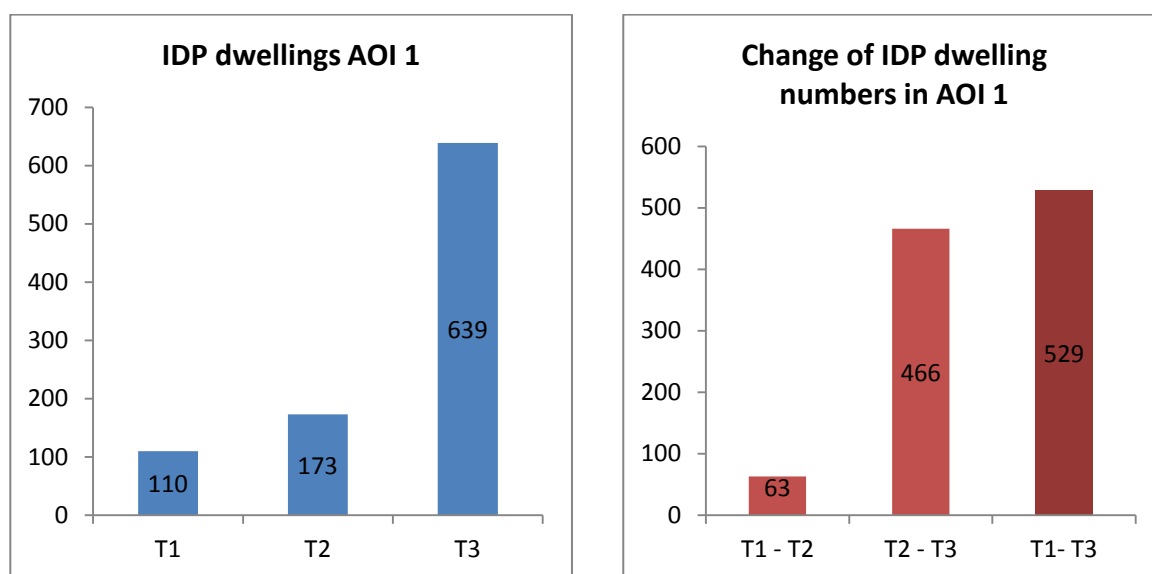
Figure 2-5: Diagram showing the development of putative IDP dwelling numbers in AOI 1 over time and the change of dwelling numbers between T1-T2, T2-T3 and T1-T3.

In total 110 putative IDP dwellings have been mapped in t₁, 173 in t₂ and 639 in t₃.

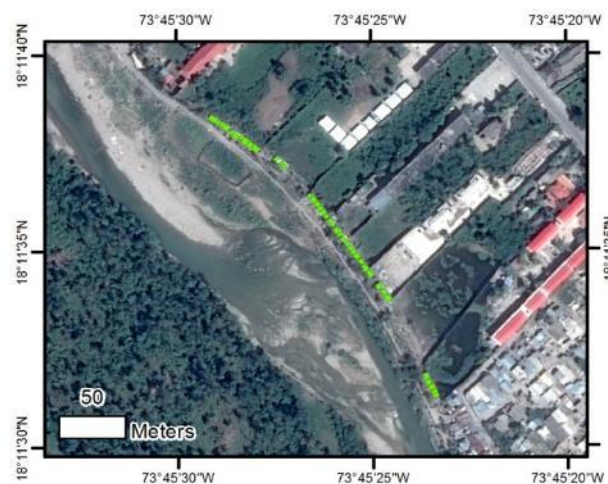
Figure 2-7: putative IDP settlement along Ravine du Sud in Les Cayes. Shown is situation at t_3 .

Further putative IDP settlements have been found along the river *Ravine du Sud*, in the western part of the town (see previous figure). The location of these small dwellings perched against the surrounding walls of neighbouring lots suggests that these are precarious housings, potentially inhabited by internally displaced persons affected by cyclone Matthew.

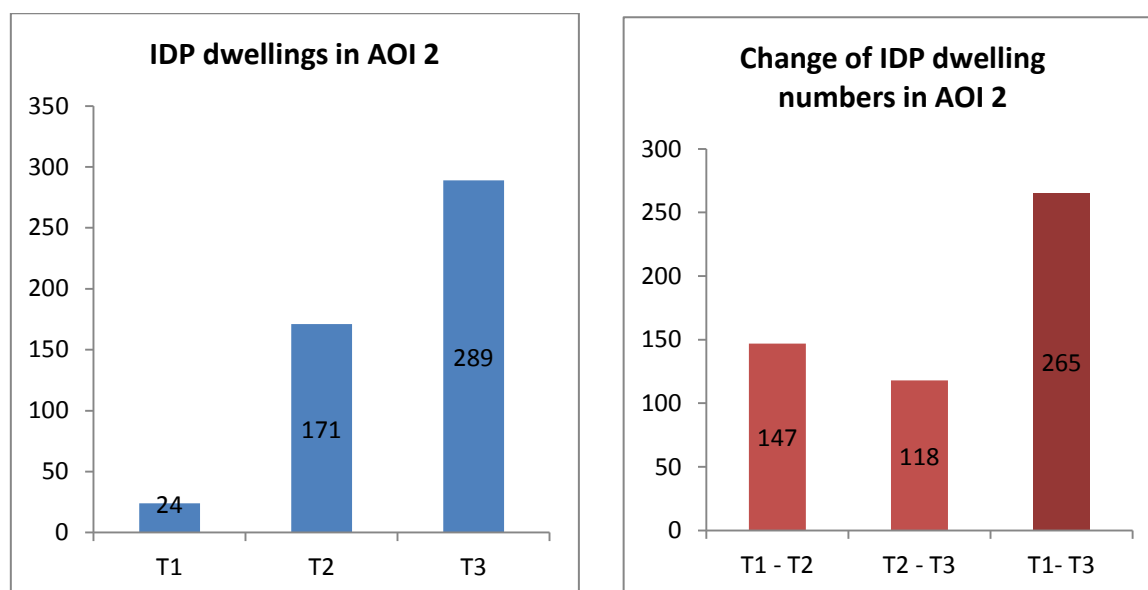
Figure 2-8: Diagram showing the development of putative IDP dwelling numbers in AOI 2 over time.

In total, 24 potential IDP dwellings were mapped in t_1 , 171 in t_2 and 289 in t_3 .

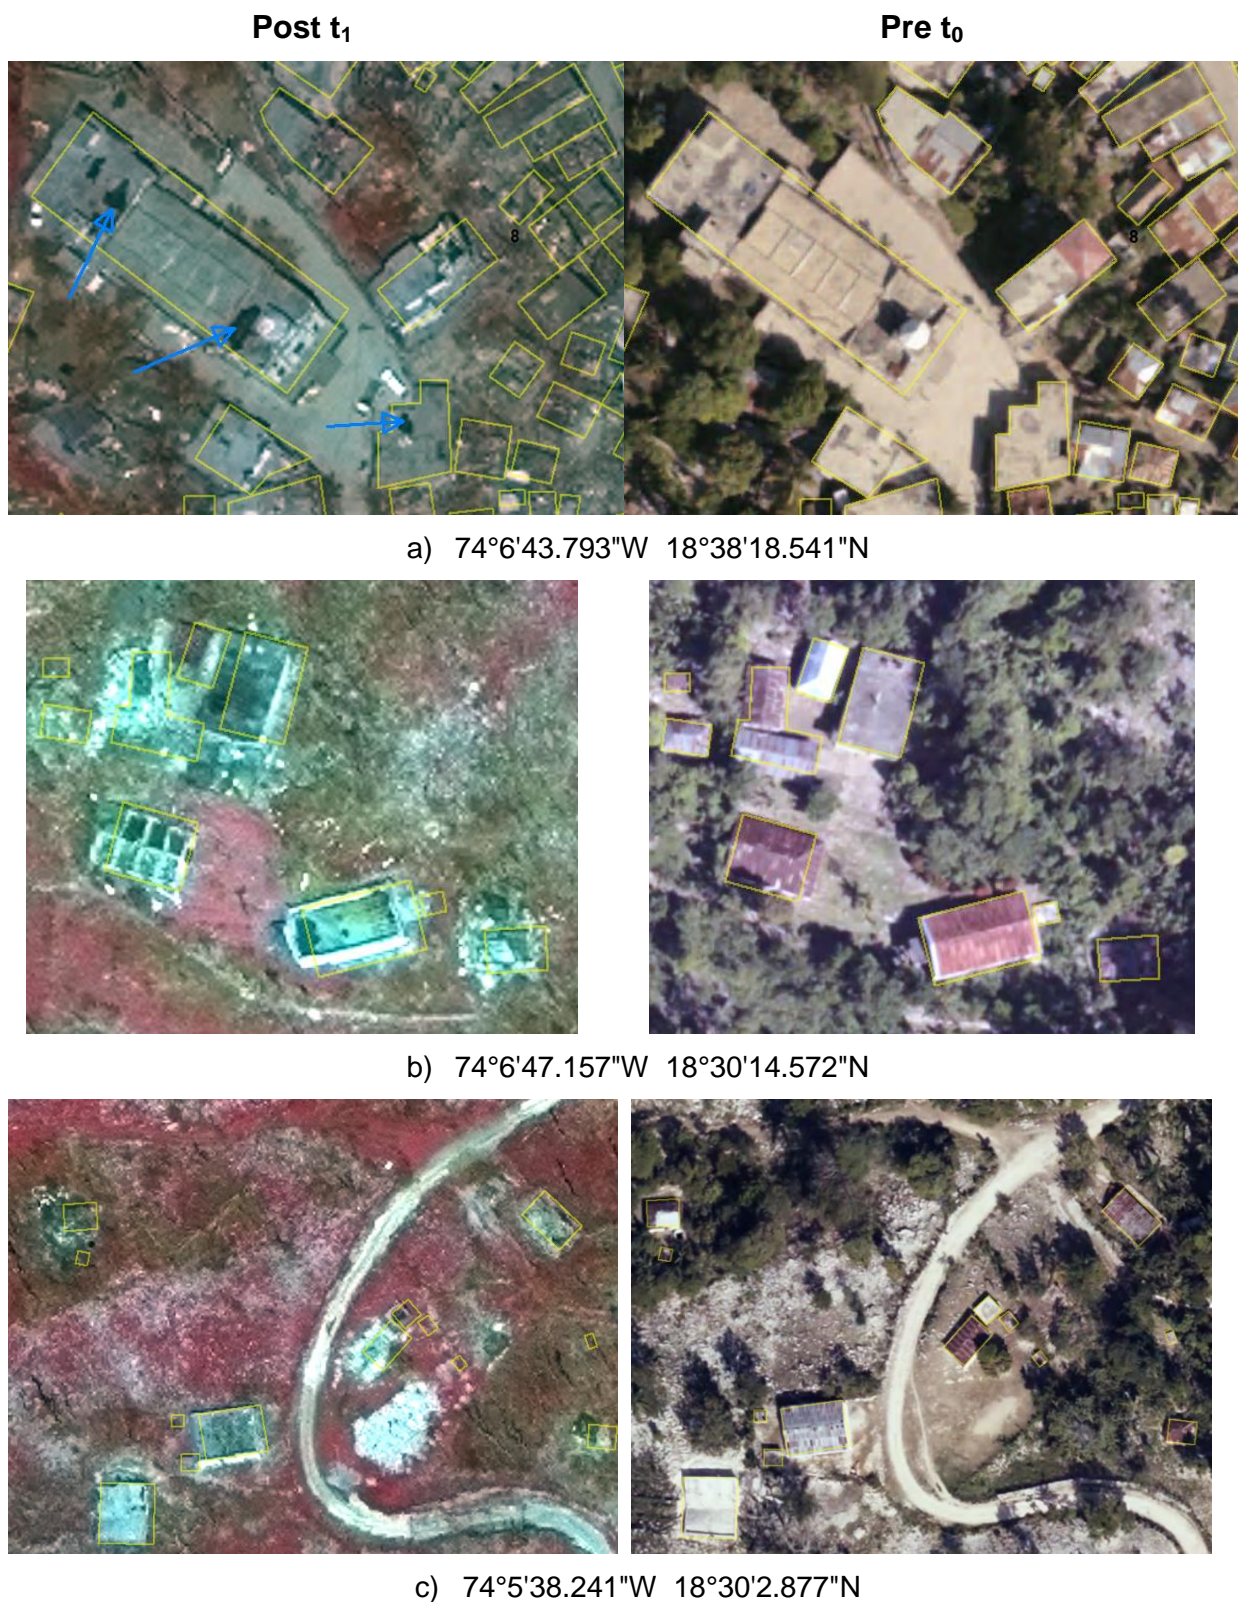
Figure 2-9: Examples of buildings in t_1 compared with pre-event t_0

In the case of buildings, the field **Status_** t_1 contains the interpretation of damage made using the corresponding imagery. If the building showed any evidence that could have potential damage, this field was coded as '*2-Damage*', while if no evidences of damages were present it was coded '*1-Not Visible Damage*'.

Water on plain roof is not considered damage, indeed this was an evidence of a solid construction made of concrete. A good example is shown in screenshots a) where there is a large building of a church with a plain roof accumulating water on top pointed by blue arrows. The majority of the building roofs made of veneer/iron sheet (rusty or not) were blown away by Mathew. These observations can be seen in all the screenshots hereinafter:

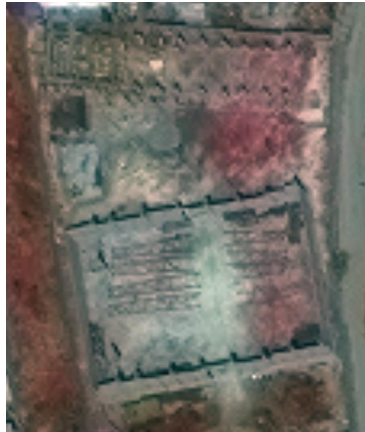
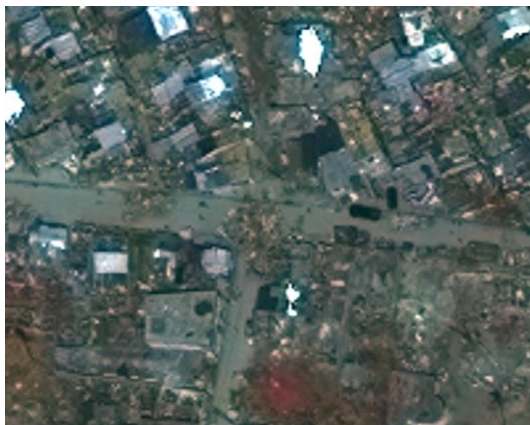
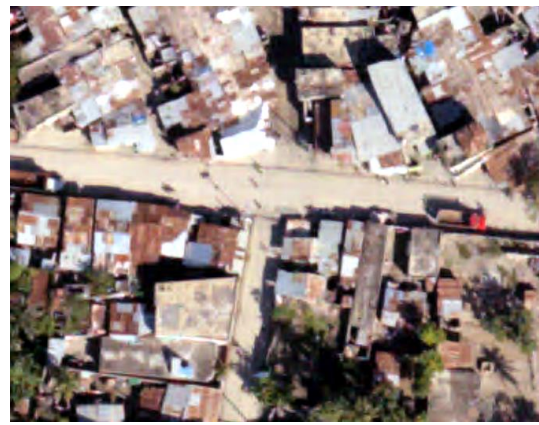
Figure 2-10: Examples of other damaged assets in t₁ compared with pre-event t₀

Damages on other assets were assessed by adding a point on the potential damages identified, referring to the affected asset, and coding the field **Status_t1**. The focus was put on infrastructures, and the majority of the detected damages were on walls (see examples a and b) and roads (c).

b) Collapsed Wall 74°7'22.268"W 18°38'26.743"N

c) Blocked Road 74°6'55.444"W 18°38'54.158"N

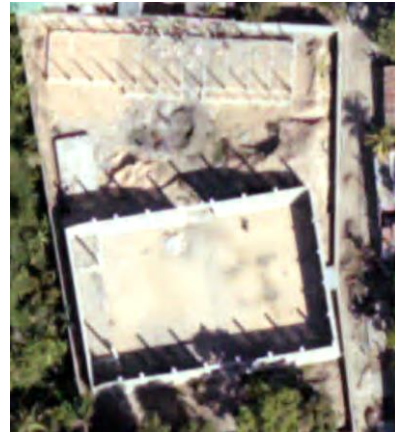
a) Collapsed Wall 74°7'13.537"W 18°38'26.021"N

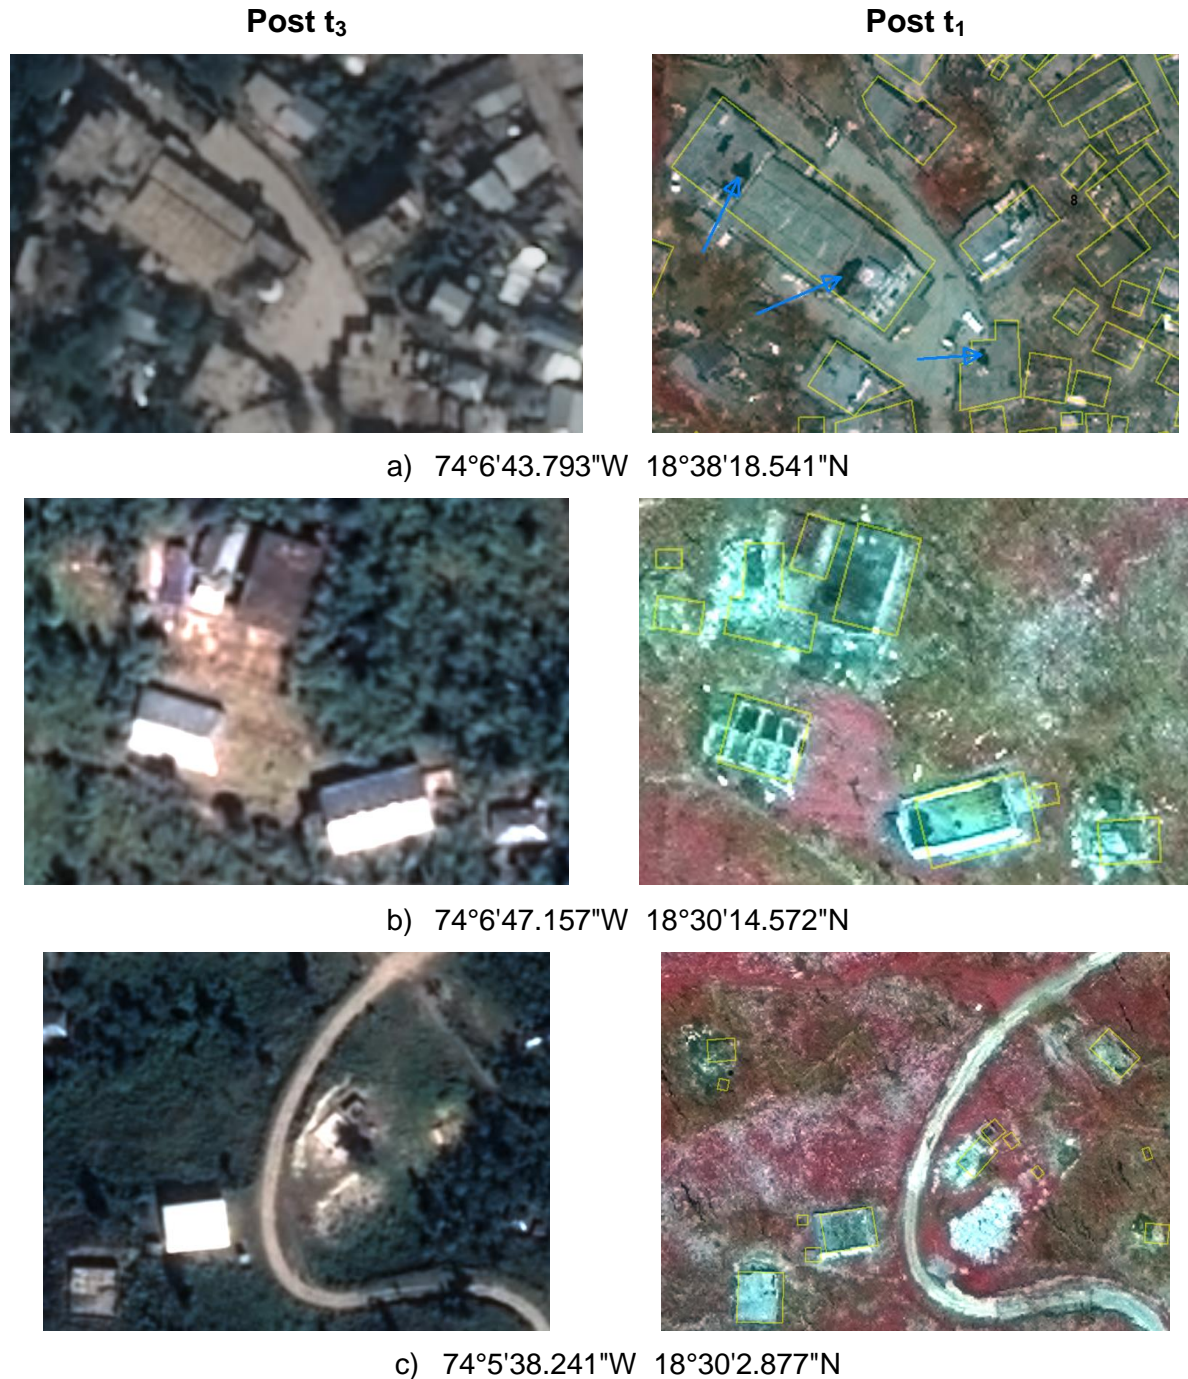
Figure 2-11: Examples of buildings in post-event t_3 compared with post-event t_1

In the case of buildings, the field **Status_** t_3 contains the interpretation of status of buildings made using the corresponding imagery approximately 12 months after the event. In the majority of the situations, the buildings showed evidences of reconstruction, and they were coded '*1-Not Visible Damage*' (a), while the buildings that still presented evidences of potential damage were coded '*2-Damage*'. There were other frequent situations such buildings that were not present in t_3 , which were coded as '*3-Cleared*' (b and c), meaning there are no evidences of being there anymore, and also new constructions that were coded as '*4-New buildings*' (b and c).

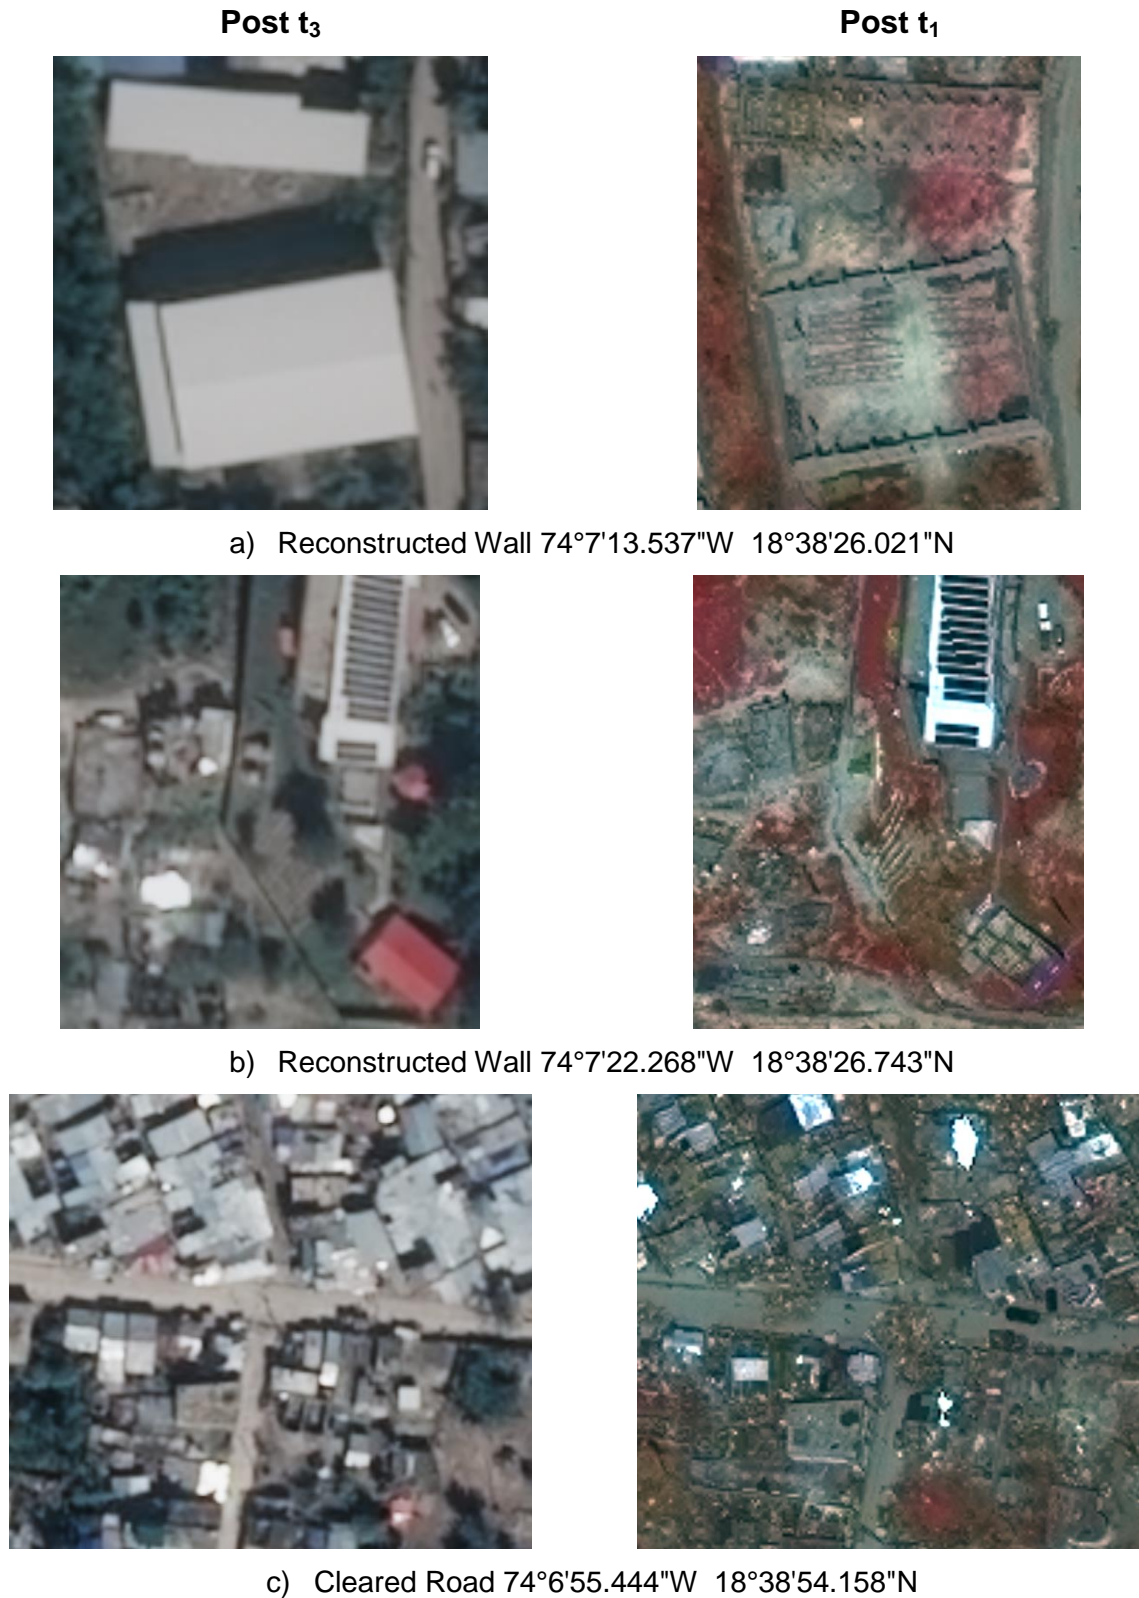
Figure 2-13: Examples of other assets in post-event t_3 compared with post-event t_1

Damages detected in t_1 were double checked in t_3 , in order to verify if the damages are solved approximately one year after the cyclone. The status in this time stage was coded in the field **Status t_3** . The majority of the detected damages in t_3 were presented signs of recovery. Some of the detected damages in t_1 could not be verified in t_3 , especially walls, because sometimes the impressive vegetation recovery, after one year, hindered the damaged features observed after the hit of Mathew, where the majority of vegetation was devastated.

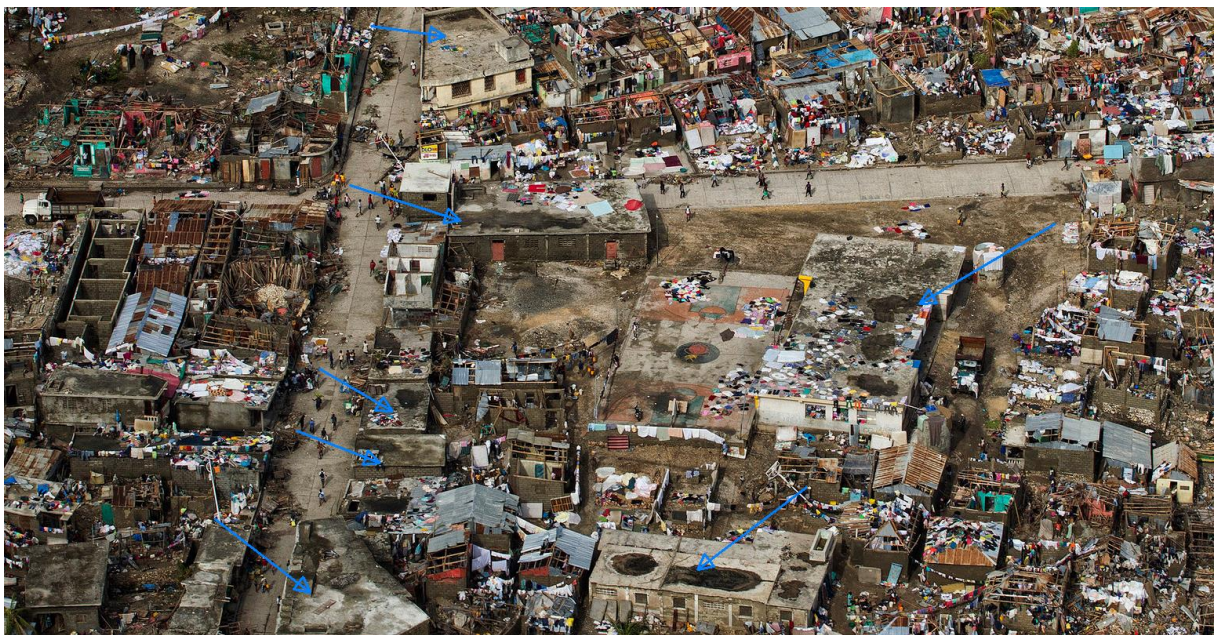
Figure 2-14: Bird's-eye view of Jérémie from MINUSTAH (example #3)

In the following picture, the street that runs from top to bottom is the *Avenue Simon Duvalier*, the one from left to right is *Abbé Huet Street*, in the northern part of the City of Jérémie (74° 6'52.54"W 18°38'53.96"N). The picture was taken from a helicopter while overflying the city looking from the West to the East; the North is to the right.

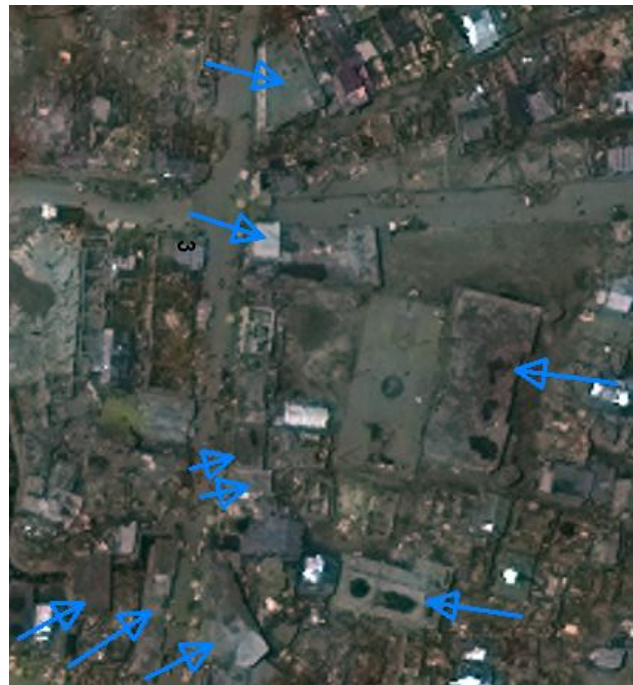
Figure 2-15: Buildings from bird's-eye view identified in the t_1 satellite image (AOI 01)⁷

Satellite imagery for t_1 can be seen in the next screenshot, and was taken on 15/10/2016, eleven days after cyclone Matthew. Apparently there are not as many clothes present on top of the buildings as they were 2 days after the event. There is still water on the rooftops of not damaged buildings. Concrete may be wet already. The vast majority of tin roofs are blown away.

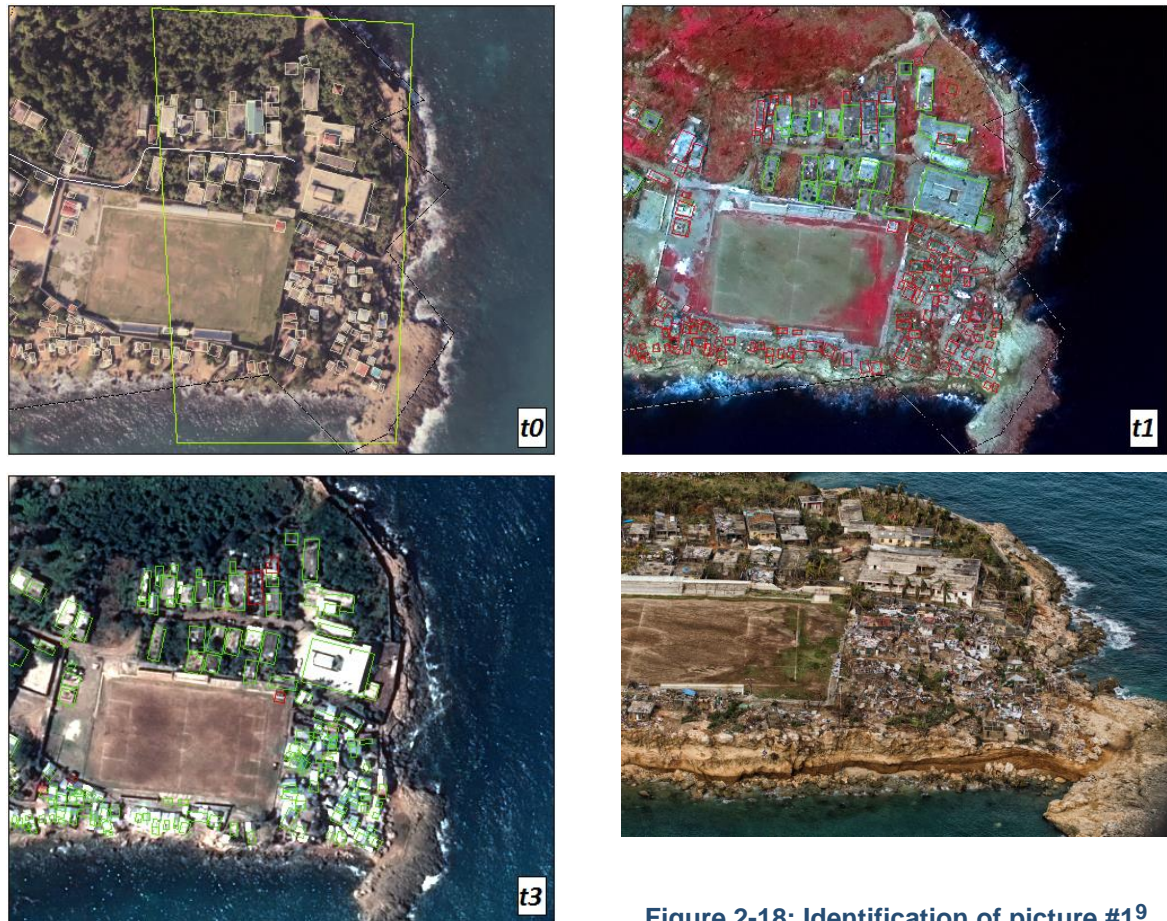
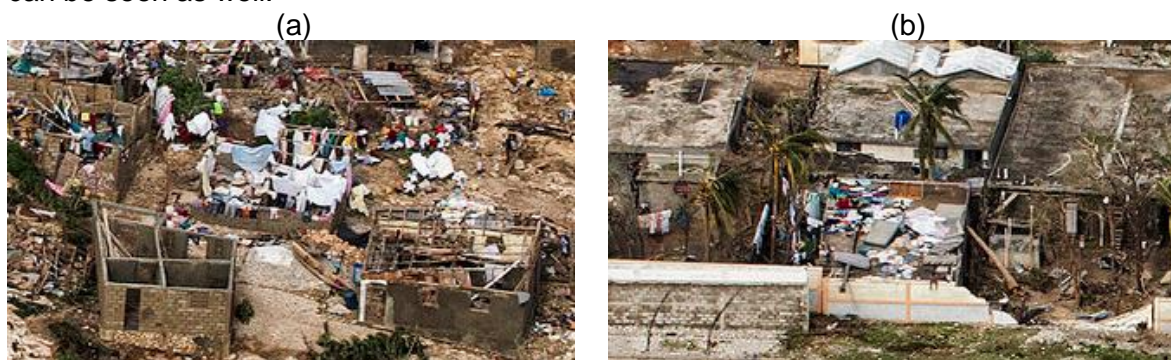
Figure 2-18: Identification of picture #1⁹

This picture was taken looking from the West to the East (the North is to the right) near *Côtes de Fer* Bight, there is a football ground and a neighbourhood to the front and left of the picture, where the houses are informal precarious and small (a). Behind the sports ground there are other type of constructions made of better building materials like concrete (b). The informal constructions are destroyed in the t_1 imagery, in the majority of them the roof was blown away. In some cases the walls are also blown away or collapsed, in some others, the walls made of bricks/concrete are still standing up. In example (b) a collapsed facility wall can be seen as well.

Figure 2-19: detail of buildings in picture #1¹⁰

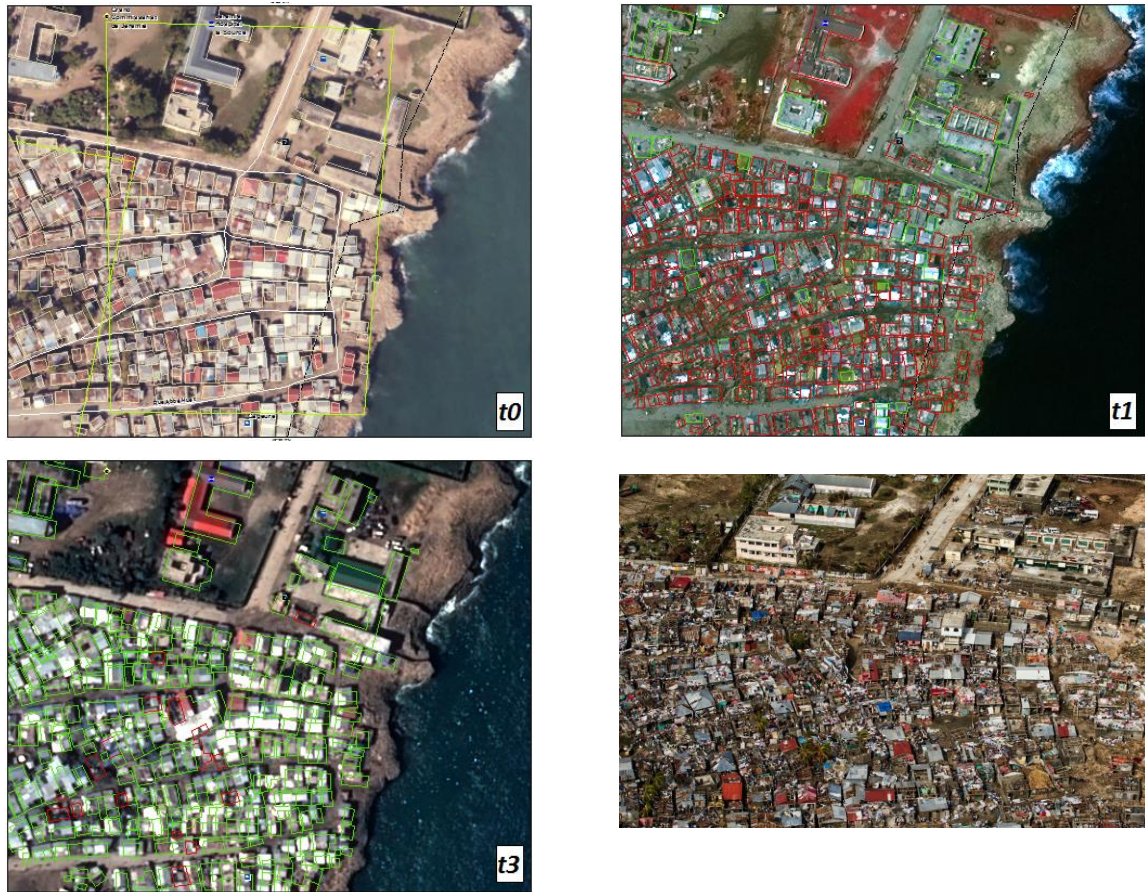
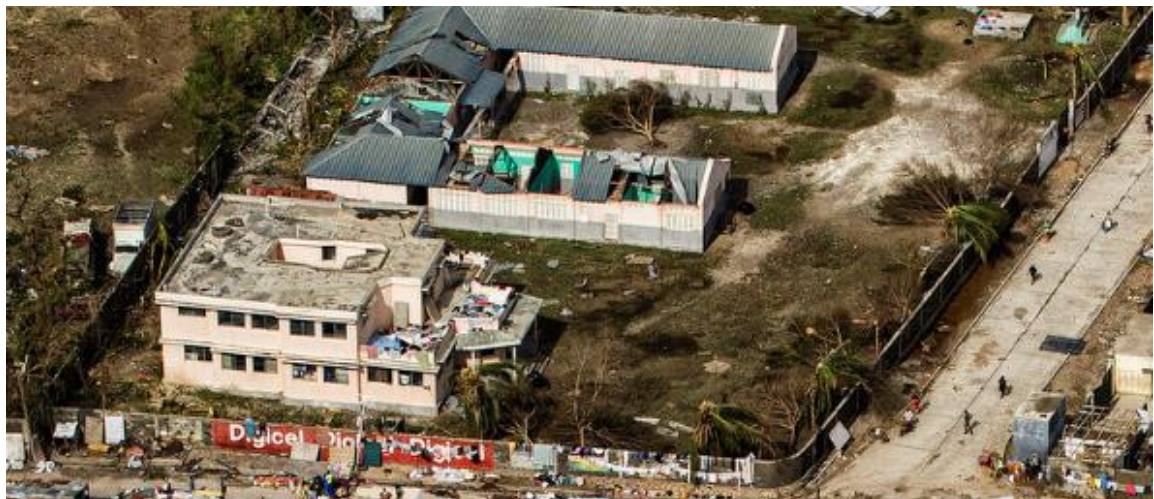
Figure 2-20: Identification of picture #211

This picture was taken looking from the West to the East (the North is to the right) while overflying the northern coast of City of Jérémie ($74^{\circ}6'55.856''\text{W}$ $18^{\circ}38'59.057''\text{N}$). The facility that can be seen at the back of the picture is Jérémie Hospital *la Source*. As seen in the detail below, a part of the Hospital with gabled tin roof was damaged (blown away roof) while the other building with flat concrete roof within the facility (at the front of the picture) looks fully functional after Mathew. The damaged building in t_1 is reconstructed one year ago t_3 . The neighbourhood at the front of the picture was majorly devastated then, but recovered nowadays at t_3 .

Figure 2-21: detail of Jérémie Hospital *la Source* facility #2

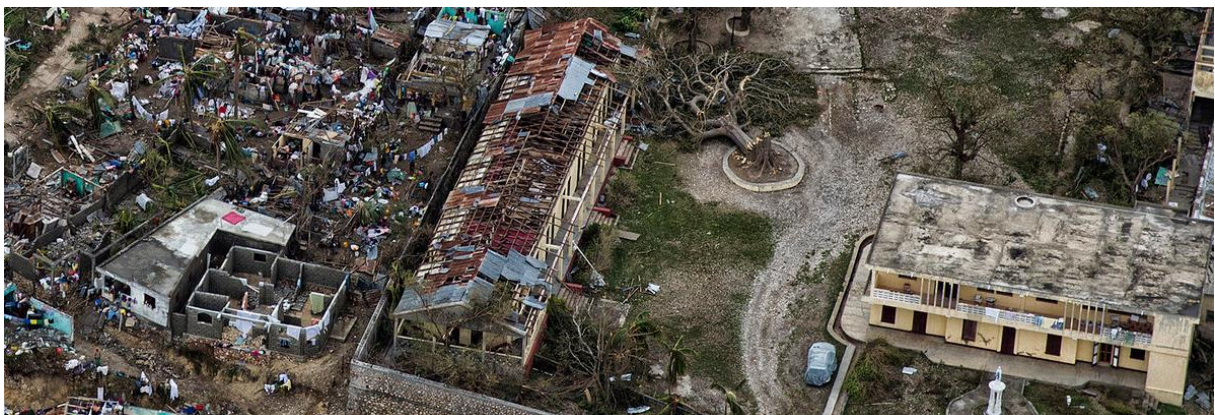
Figure 2-22: Identification of picture #4¹²

This picture was taken looking from the West to the East (the North is to the right) while overflying the City of Jérémie (74°6'57.996"W 18°38'34.152"N). The main visible facility to the right of the picture is Asylum Hospital *Notre-Dame de Lourdes*. There are several buildings within the facility, and again, as observed in the previous example the gabled tin roof was blown away (to the left of the facility) while the flat concrete roofed buildings within the facility look functional. The majority of the buildings to the left of the facility wall look damaged in the near post-event t_1 , and reconstructed one year after the event t_3 .

Figure 2-23: detail of Jérémie Asylum Hospital Notre-Dame de Lourdes facility #4

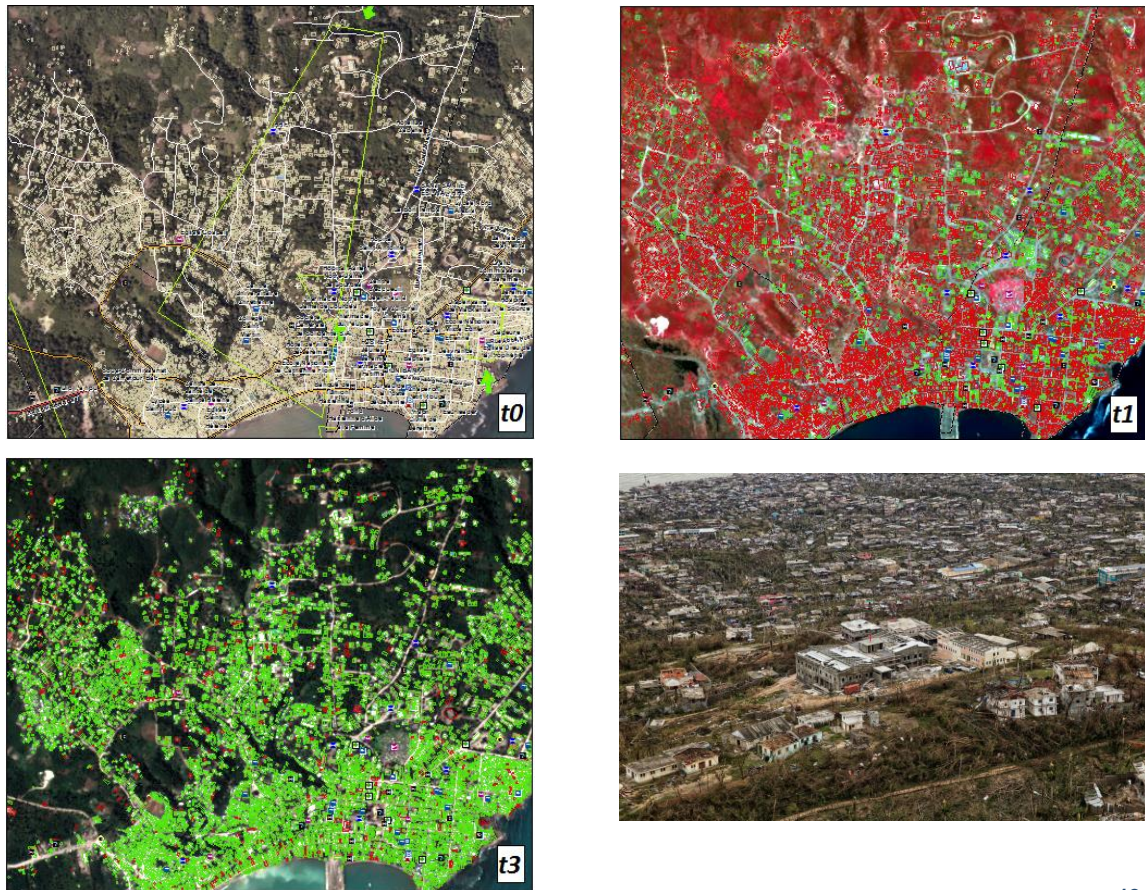
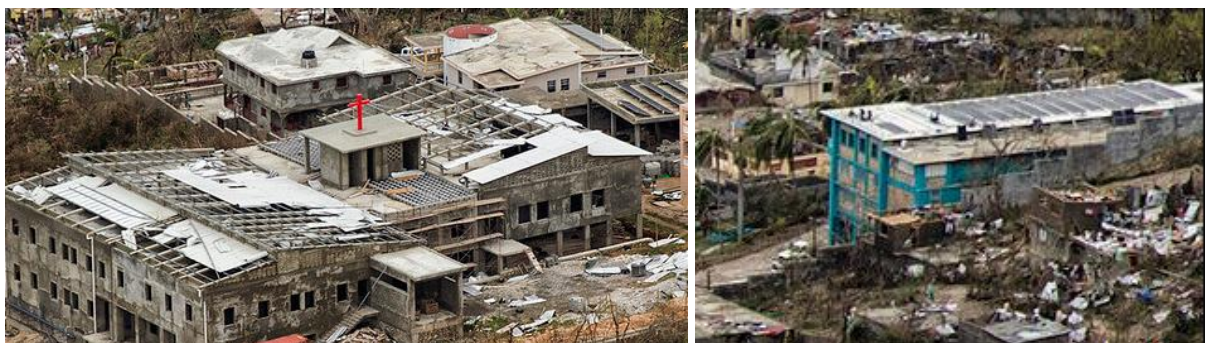
Figure 2-24: Identification of picture #5¹³

The facility at the front of the picture is religious (red cross on top) but its name is unknown, no ancillary data was available. At the left of the picture, it is also visible the HHF Hospital, with possible solar panels on top, which presents evidences of being functional in t_1 .

Figure 2-25: detail of religious and medical facilities in picture #5

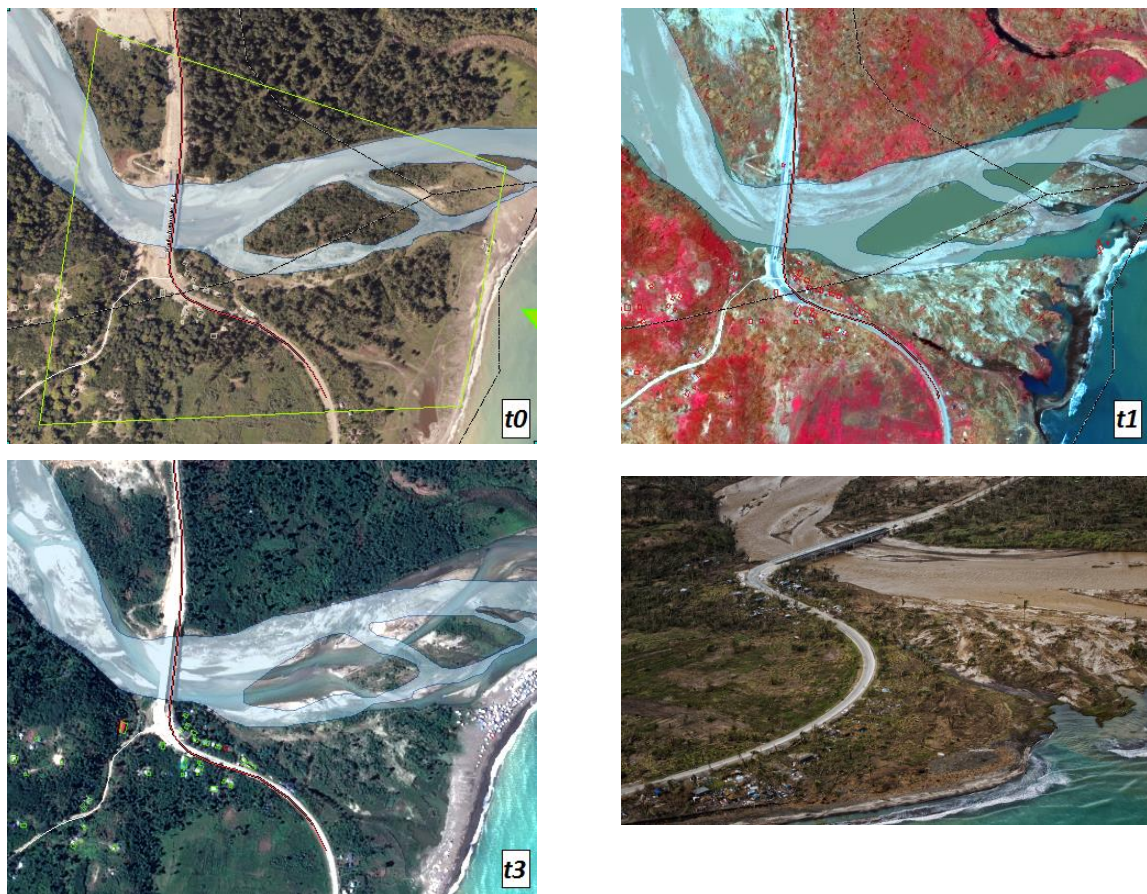
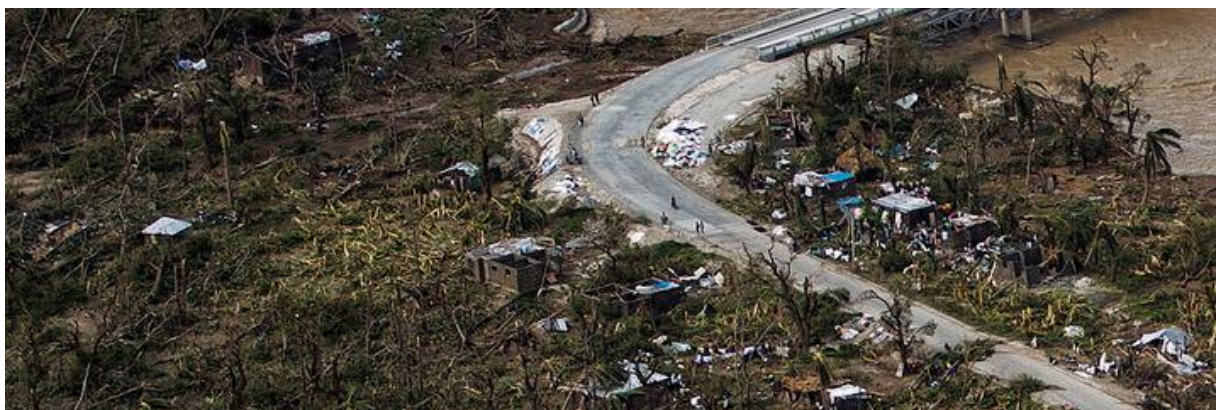
Figure 2-26: Identification of picture #6¹⁴

This picture is taken NW to SE at the western boundary of AOI 01 Jérémie, at the crossing of *Route Nationale #7* over The *Voldroque* River mouth close to *Vieux Bourg de Jérémie*. The status of the road and the bridge look functional. The hamlet by the road look affected and in the picture it is also visible how the people dry their clothes on the ground surface. The trees and palm trees are visibly affected in t_1 (no shadows projected in satellite imagery), most of them lying down on the ground. One year after Mathew in t_3 , the settlement look recovered (roofs rebuilt), and so the vegetation which presents a very good self-recovery.

Figure 2-27: detail of hamlet and vegetation in picture #6

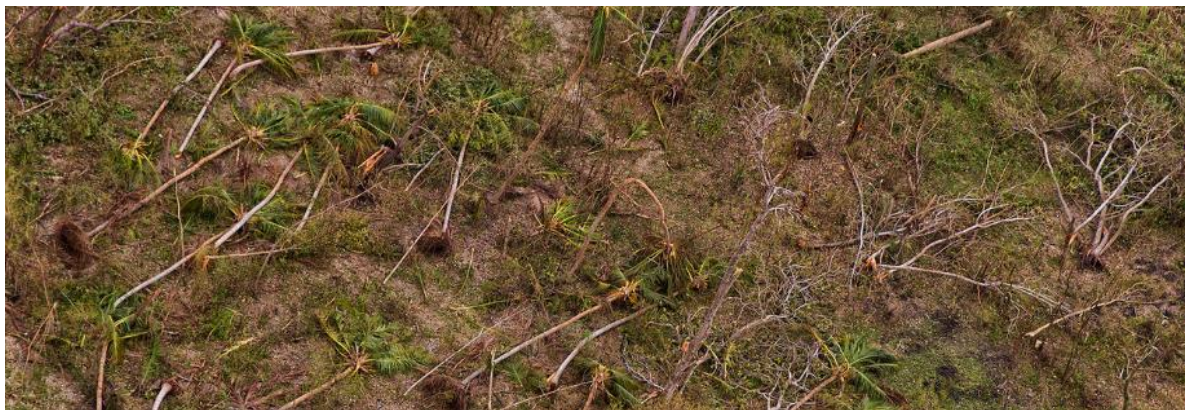
Figure 2-29: Devastation on arboreal vegetation 16

As seen in previous picture, there was a vast devastation on arboreal vegetation. It is visible in several pictures before, in next picture, there is a closer look.

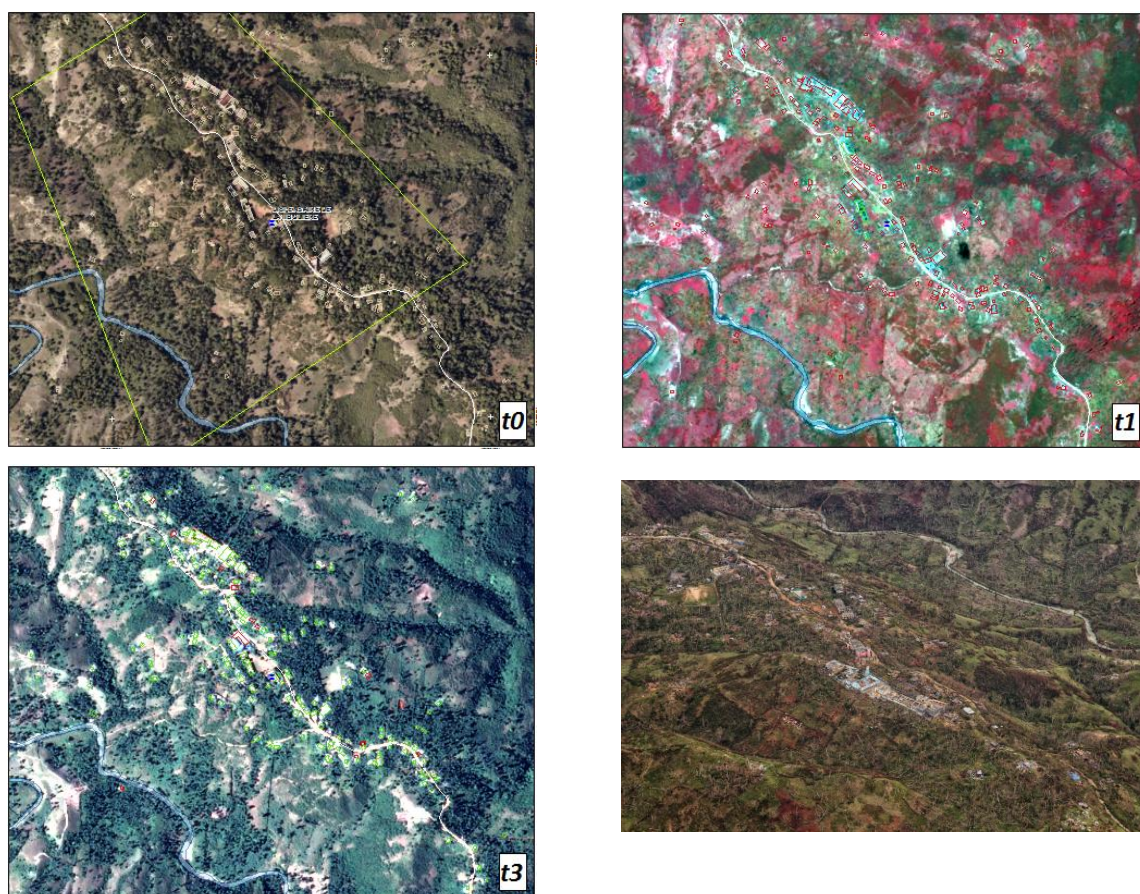
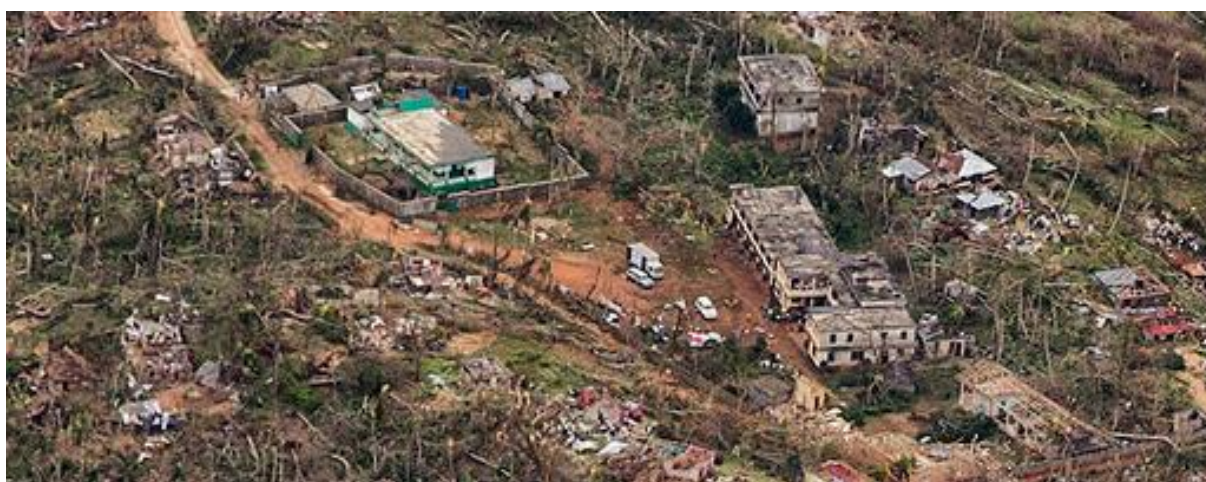
Figure 2-30: Identification of picture #8¹⁷

In this picture it is portrayed the rural populated place of *Latiboliere*. In the middle of the picture (with a white and green façade) it is possible to see the *Dispensarie de Latiboliere*, surrounded by a wall. All the facility looks functional right before the hit of Mathew. The residential building at the surroundings look damaged in t_1 and almost all recovered in t_3 .

Figure 2-31: detail of *Dispensarie de Latiboliere* in picture #8

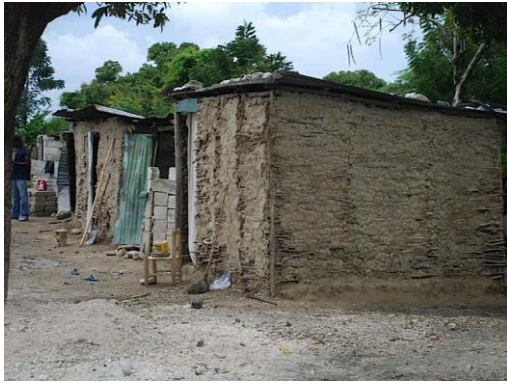
House with *clissage*²⁰ walls and plain roof probably wooden boards or tin planks²¹

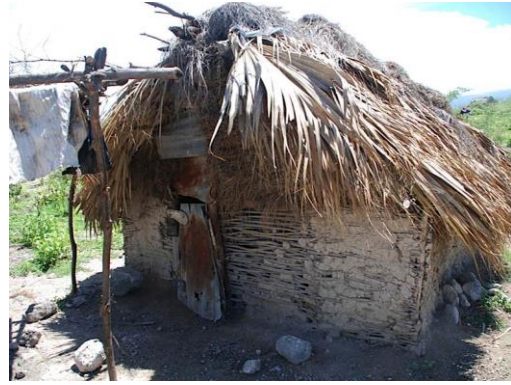
House with earthen walls and palm leaves double gable roof²²

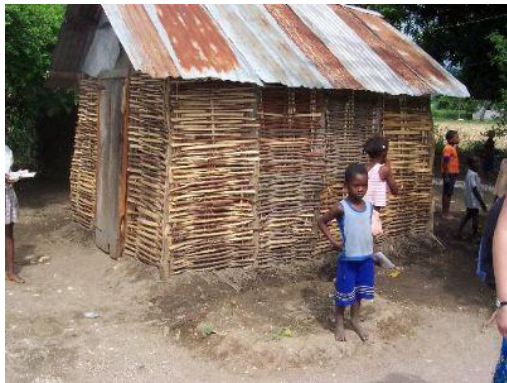
House with walls and palm leaves double gable roof²³

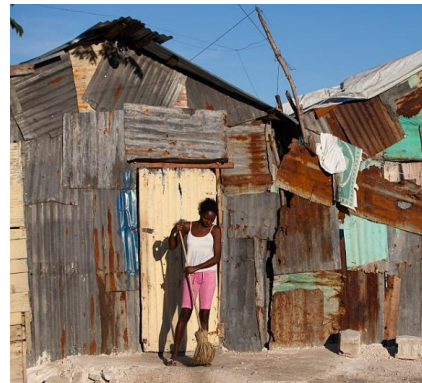
Slum house made of pieces of tin planks²⁴

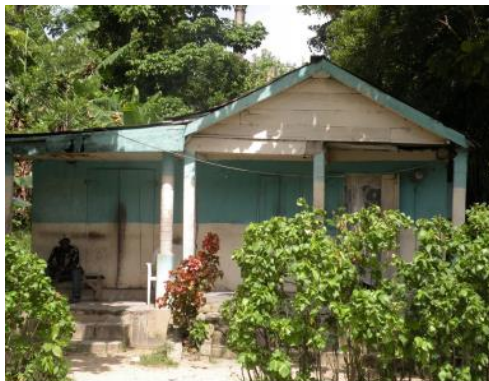
Wooden house with traditional gabled roof²⁵

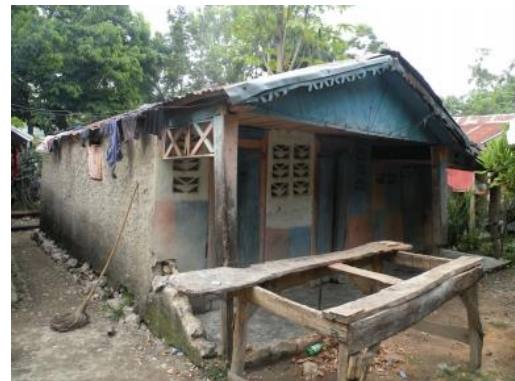
Wattle and daub house with gabled roof and front porche²⁶
