**FRAMEWORK SERVICE CONTRACT FOR
COPERNICUS "EMERGENCY MANAGEMENT
SERVICE - RISK AND RECOVERY MAPPING"**

**EMSN-050:
Post Mathew Damage Assessment and Monitoring
of Recovery Activities in the South Region of Haiti
FINAL REPORT**

August 2018

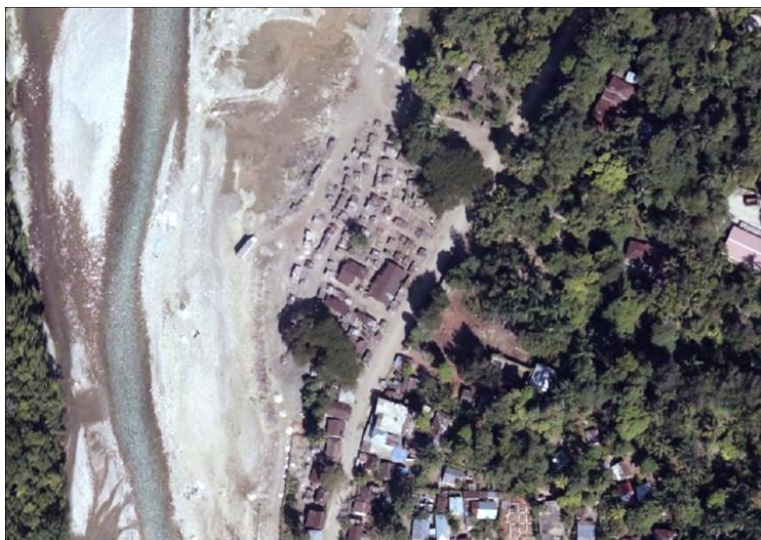
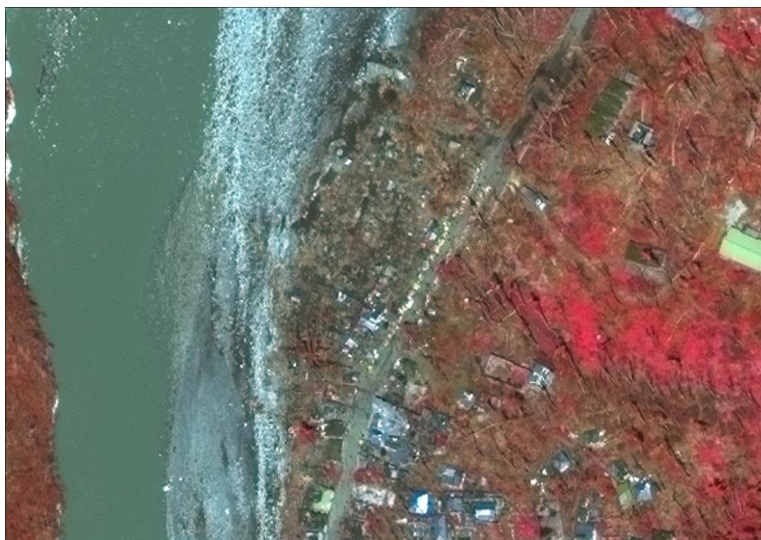
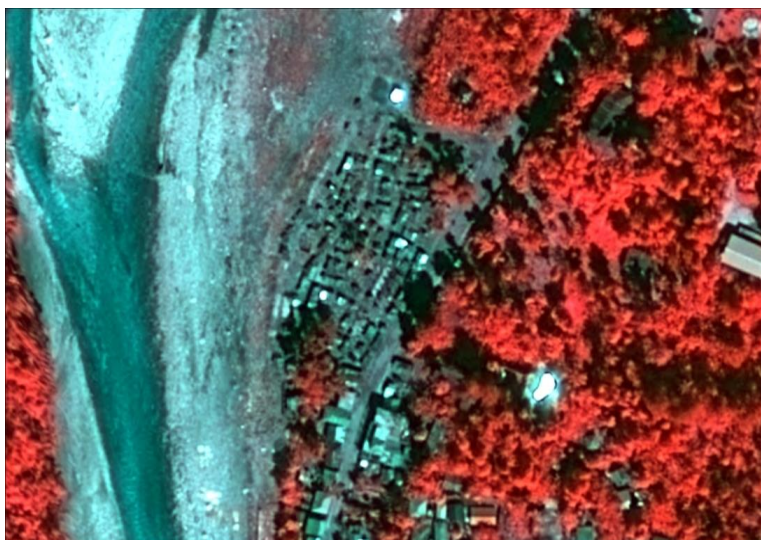
| Time stage | Images | Observations |
|---|--|---|
| t_0 | | A small concentration of buildings close to the river shoreline is visible in t_0 . In t_1 those buildings were devastated by the hurricane. In t_3 , this building concentration was recovered, with a new distribution and brand new buildings. |

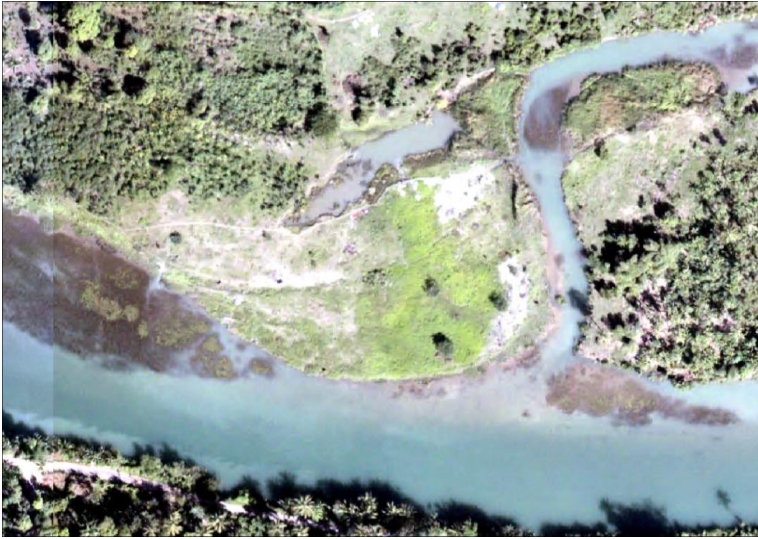
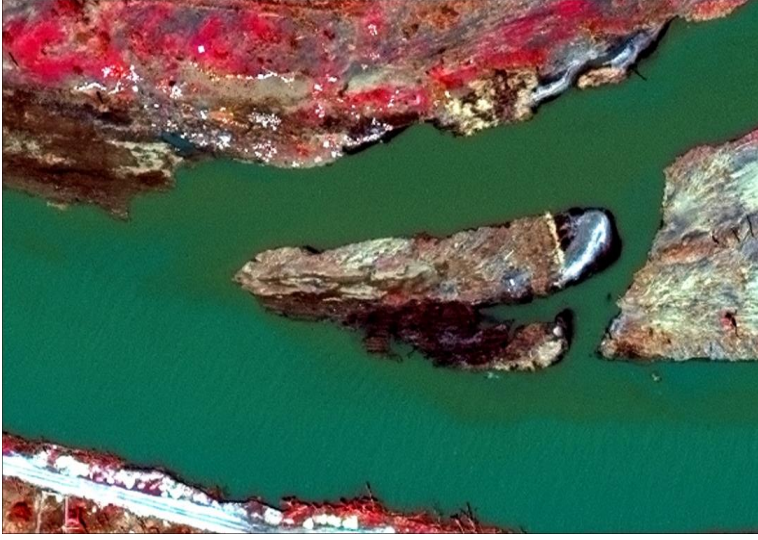
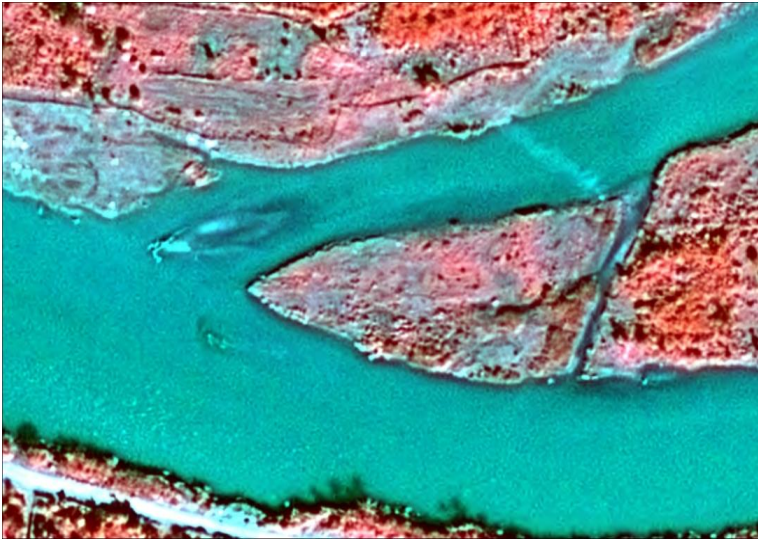
| Time stage | Images | Observations |
|---|--|---|
| t_1 | | <p>This riverbank observed in t_0 was overflowed by the river flood caused by the hurricane. The riverbank has been turned into an island in t_1. In t_3 the river channel has been modified and the river banks have emerged but the island still isolated.</p> |

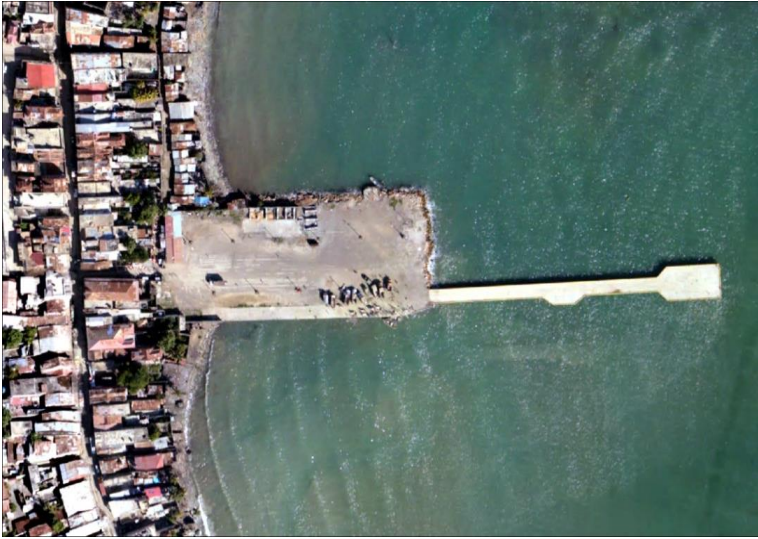
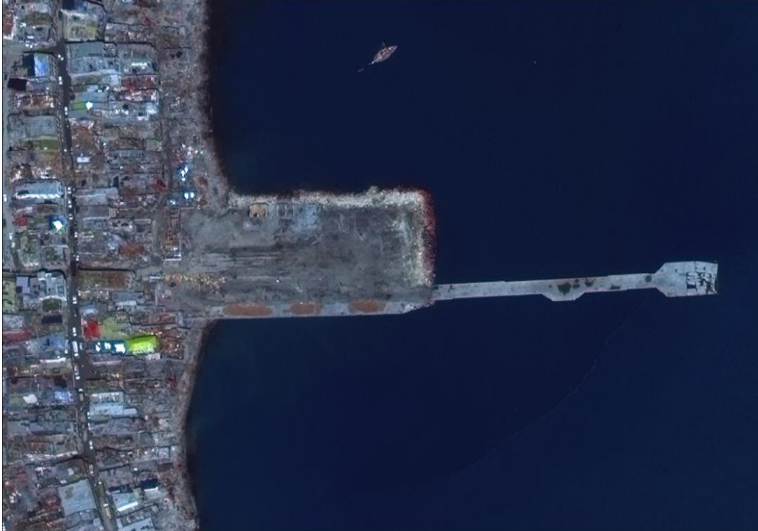
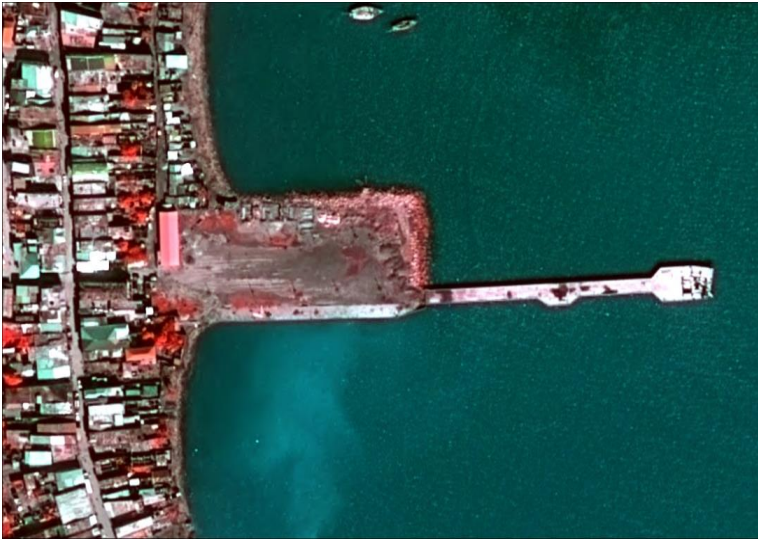
| Time stage | Images | Observations |
|---|--|--|
| t_1 | | The berthing structure observed in t_0 was damaged by the hurricane. The quay was completely damaged in t_1 and it stills damaged in t_3 . |

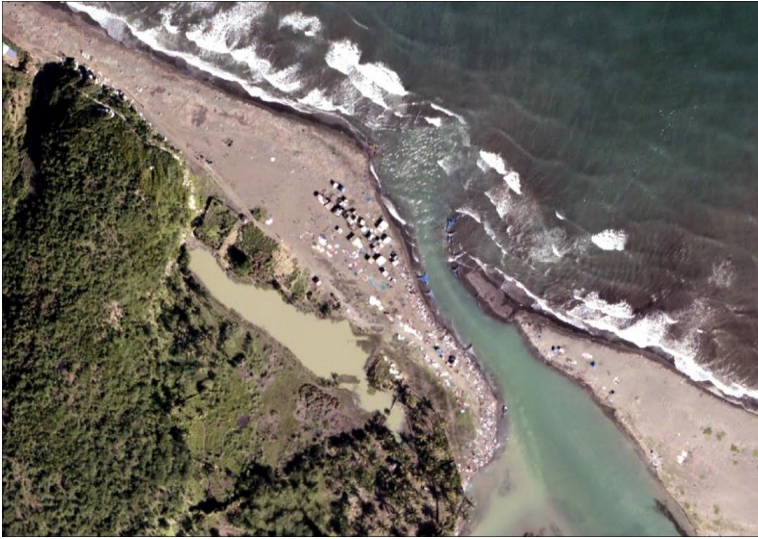
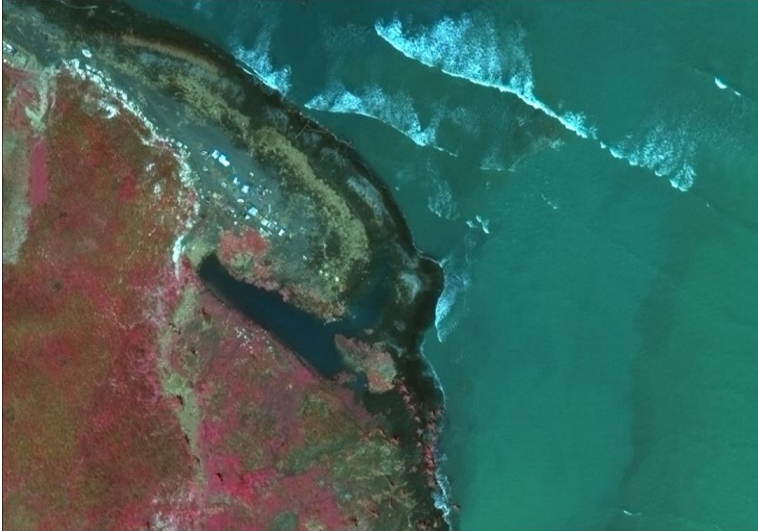
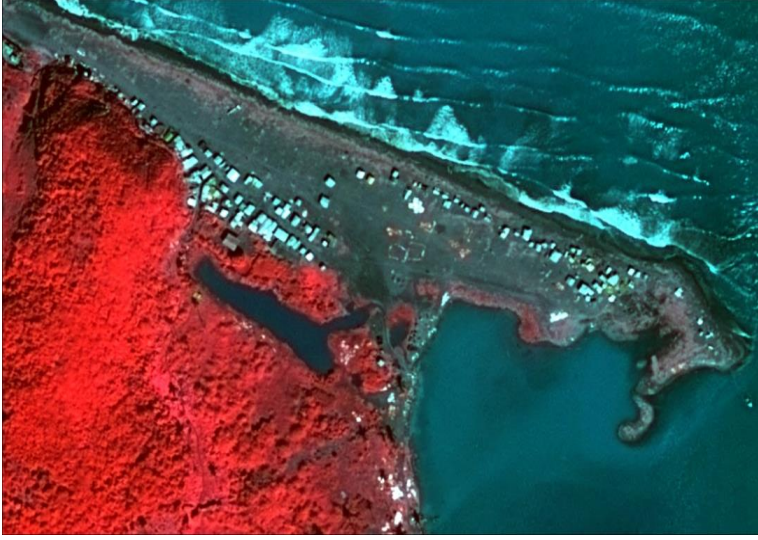
| Time stage | Images | Observations |
|---|--|---|
| t ₁ | | <p>The camp located in the river mouth in t₀ was severely damaged by the hurricane in t₁. The river mouth was modified in t₁ and the camp was destroyed. In t₃ the river mouth has been modified again and a new camp has arisen.</p> |

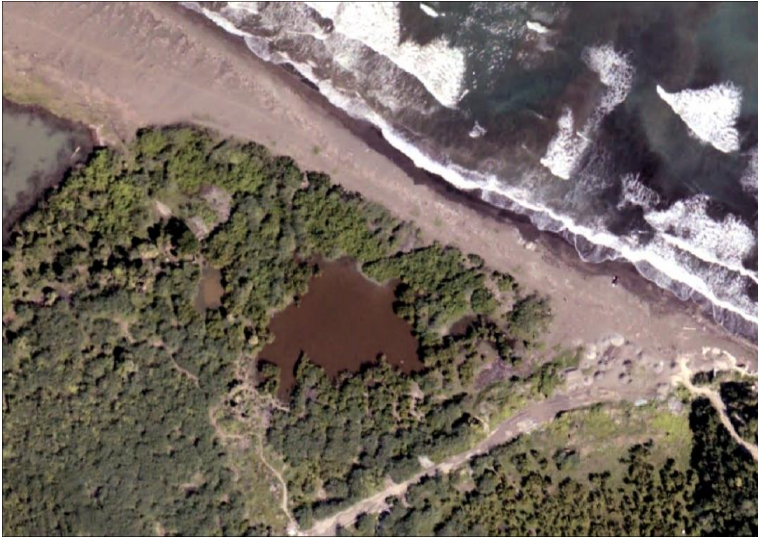
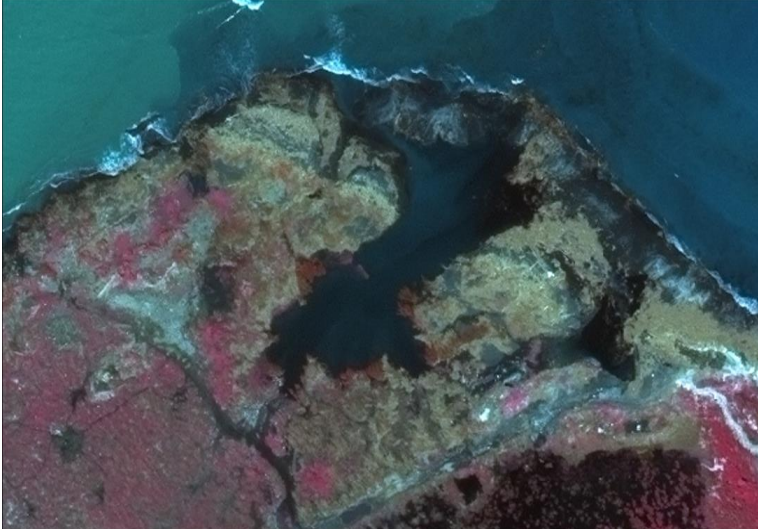
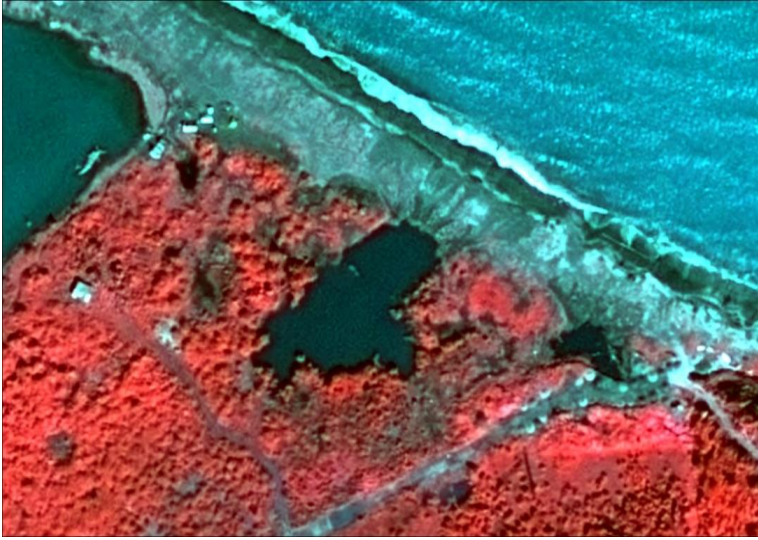
| Time stage | Images | Observations |
|---|--|---|
| t_1 | | <p>The coastal wetland observed in t_0 was delimited by the sand beach. It was overwhelmed by the tidal water in t_1. The sand beach has been recovered in t_3 and the wetland is separate from the sea again.</p> |

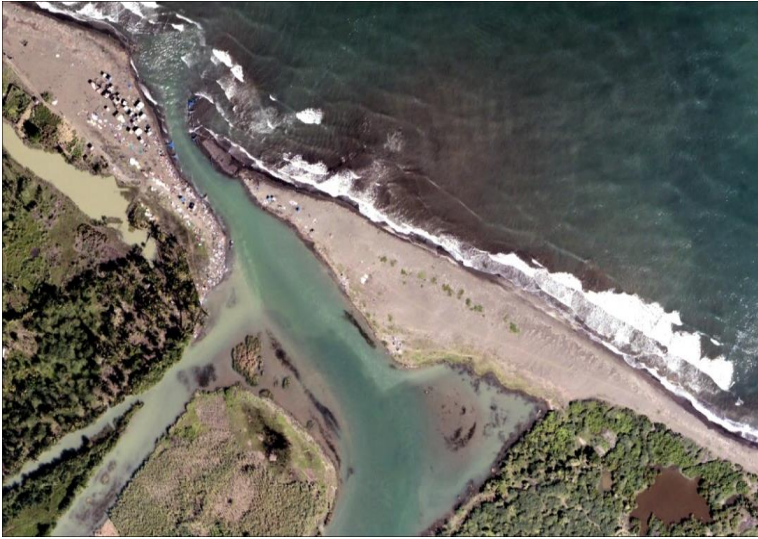
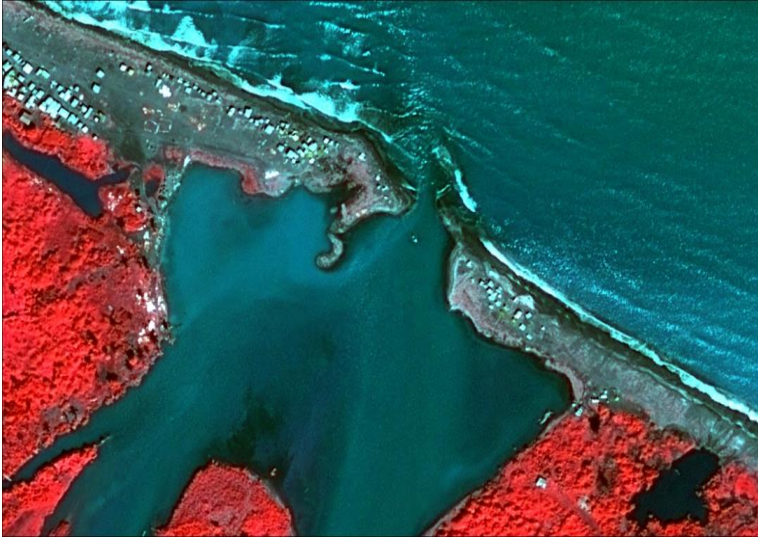
| Time stage | Images | Observations |
|---|--|--|
| t_1 | | The sand bar located in the river mouth in t_0 was completely removed in t_1 after the hurricane. In t_3 the sand bar has been naturally recovered in a different shape and the buildings located have been resettled. |

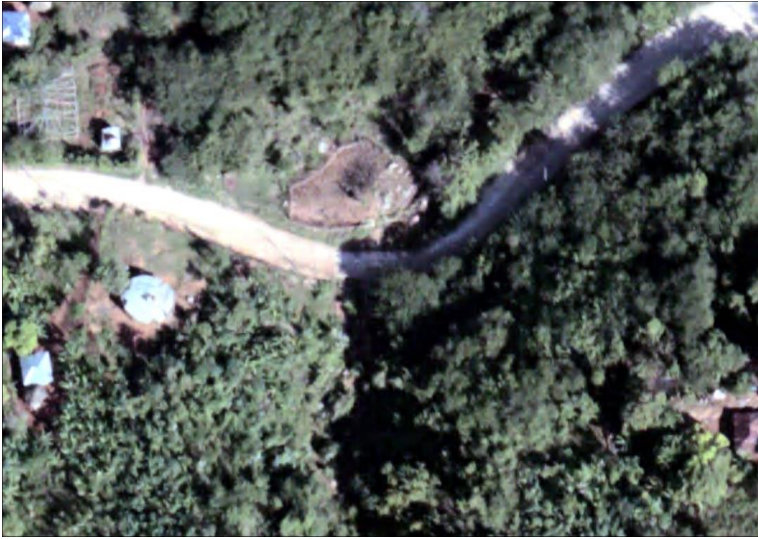
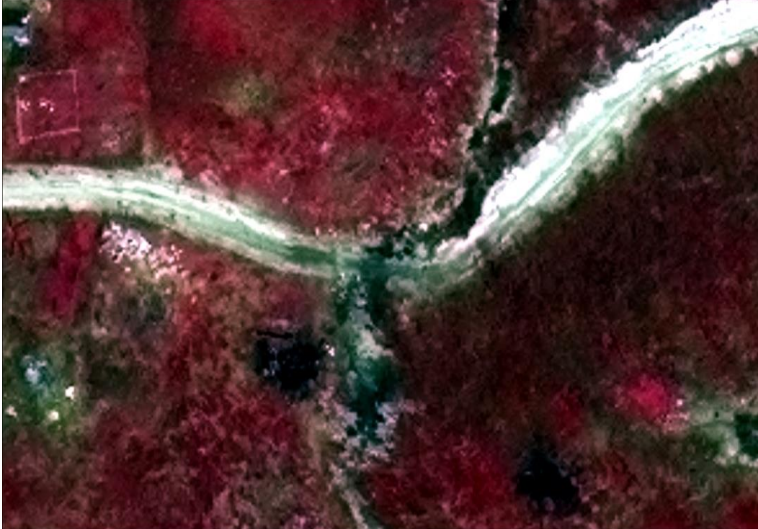
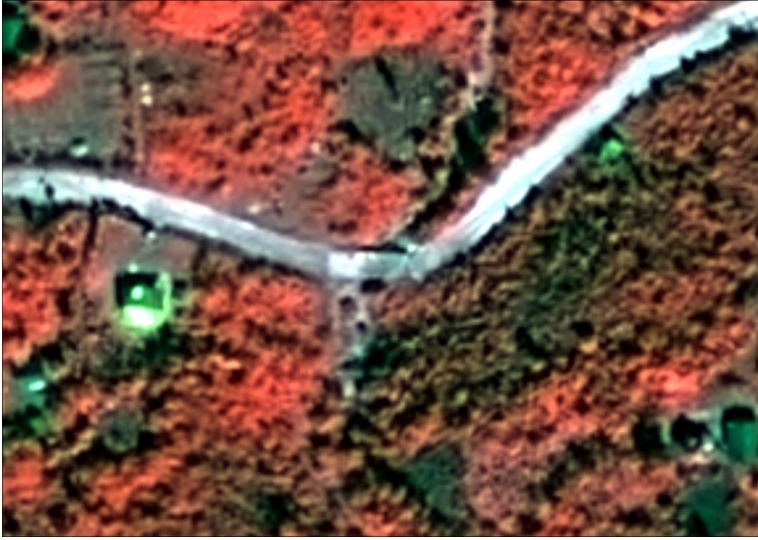
| Time stage | Images | Observations |
|---|--|---|
| t_1 | | <p>This bridge was removed by the river flood caused by the hurricane in t_1. In t_3 it has been rebuilt.</p> |

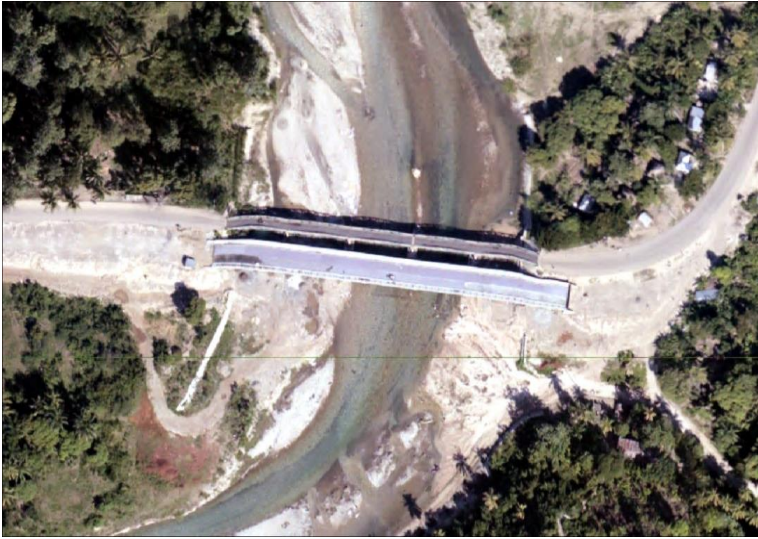
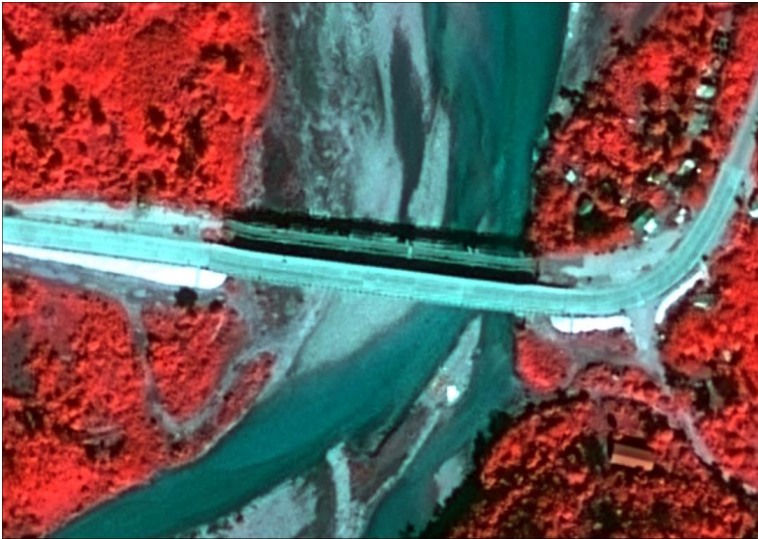
| Time stage | Images | Observations |
|---|--|---|
| t_1 | | <p>These bridges were affected by the hurricane in t_1. They have been completely cleaned in t_3.</p> |

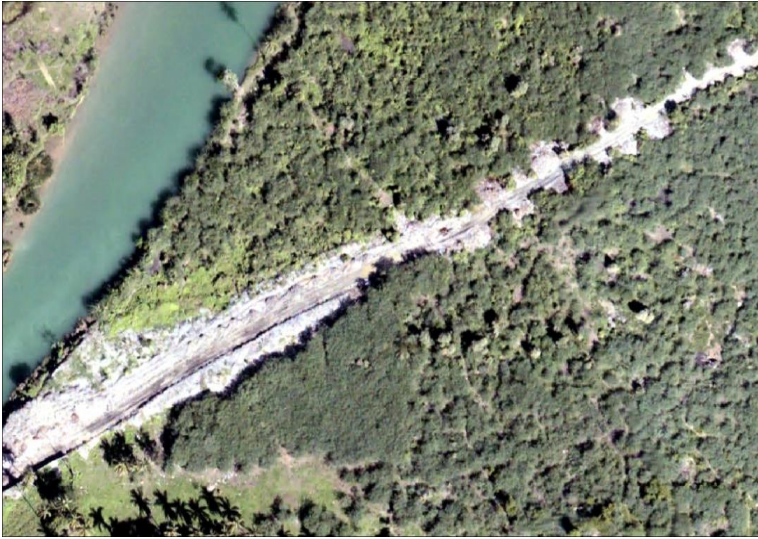
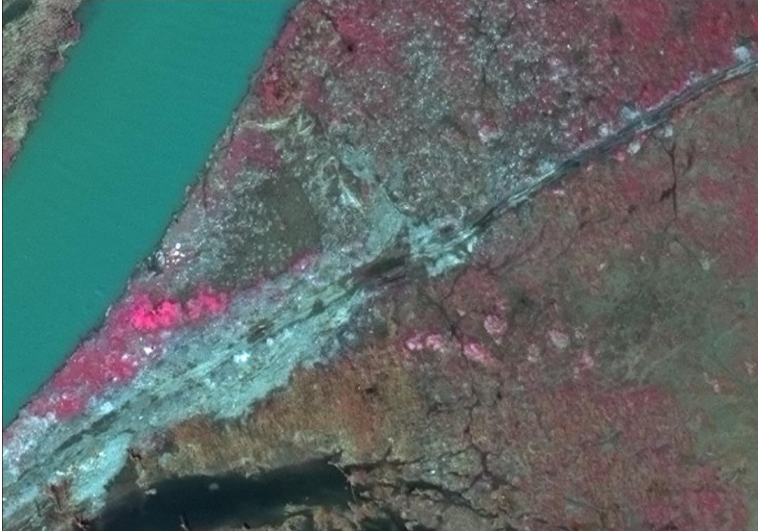
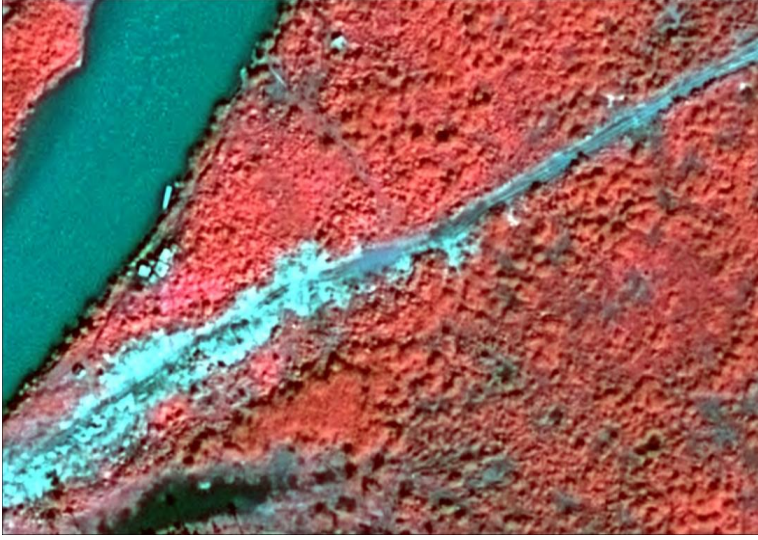
| Time stage | Images | Observations |
|---|--|---|
| t_1 | | <p>This road was closed by the river flood caused by the hurricane in t_1. It has been partially reopened in t_3 but it still damaged in some points.</p> |

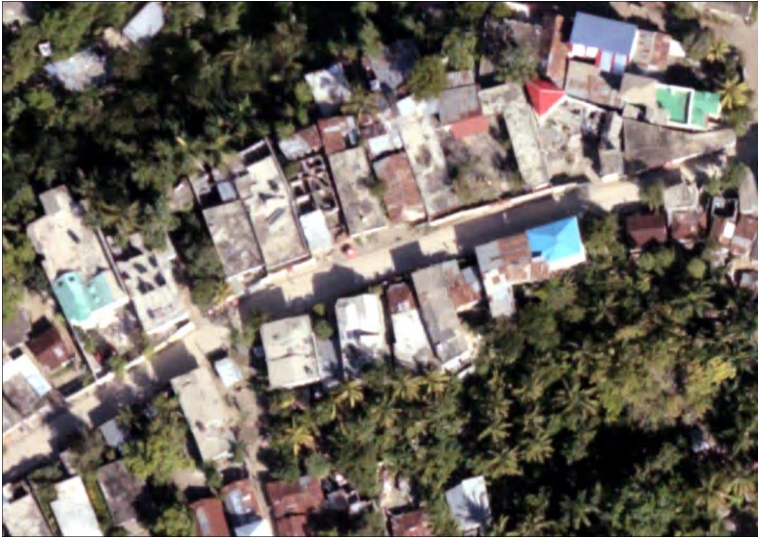
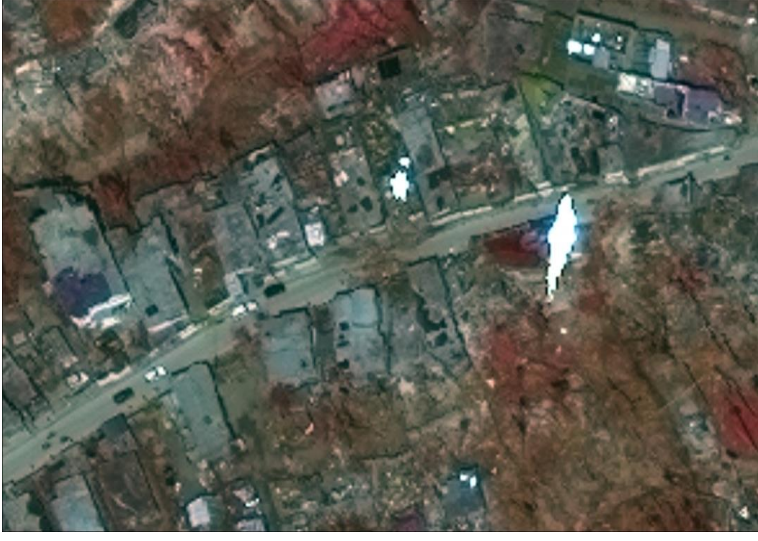
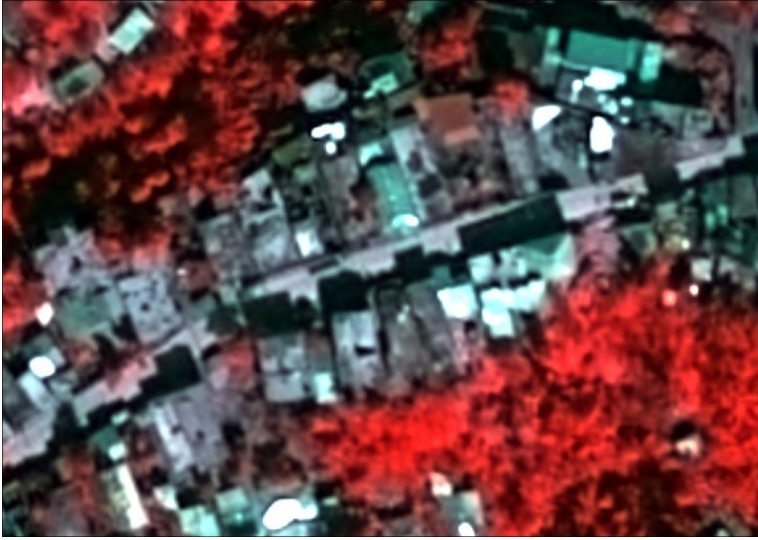
| Time stage | Images | Observations |
|---|--|---|
| t_1 | | <p>The buildings collapse caused by the hurricane provokes debris barriers along this street in t_1. In t_3 the street is clean and the buildings are mostly rebuilt.</p> |

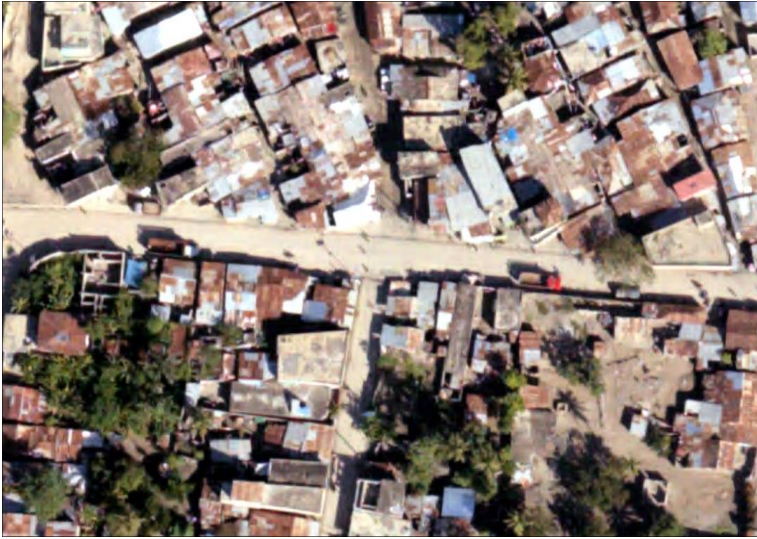
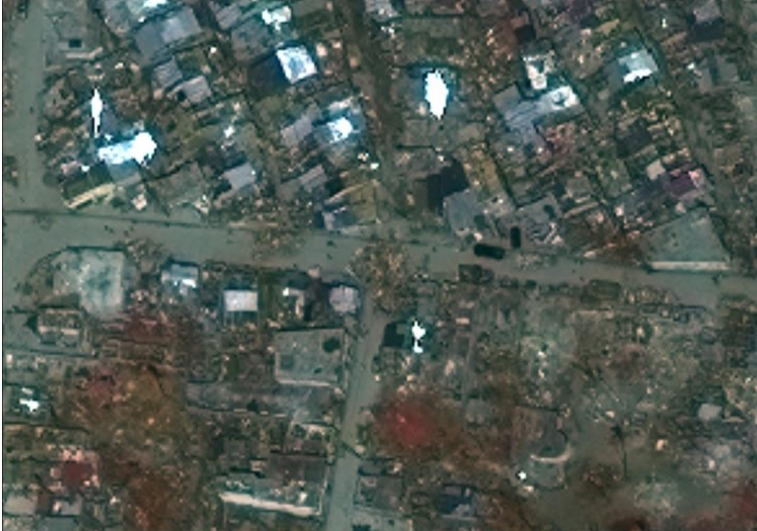
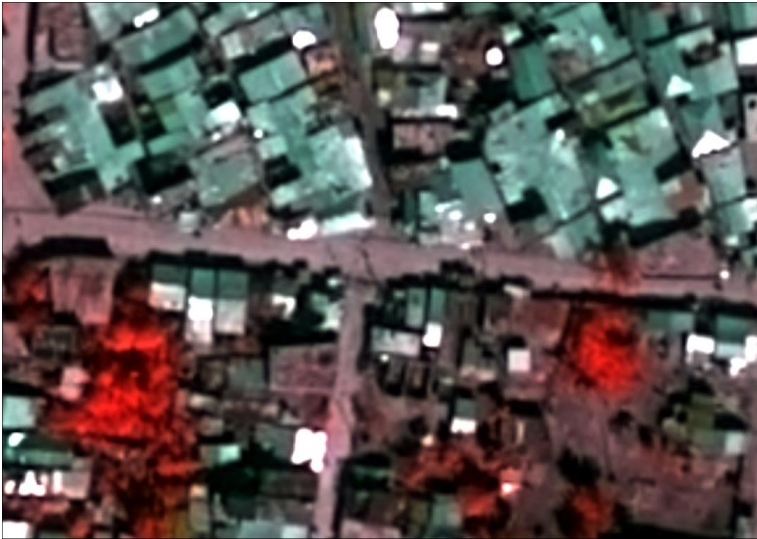
| Time stage | Images | Observations |
|---|--|--|
| t ₁ | | <p>After the hurricane, the debris was collected along the streets in order to facilitate the access and allow the trafficability. In this case, the debris was storage in the intersection in t₁.</p> <p>In t₃, the streets are completely clean as well as the buildings are mostly rebuilt.</p> |

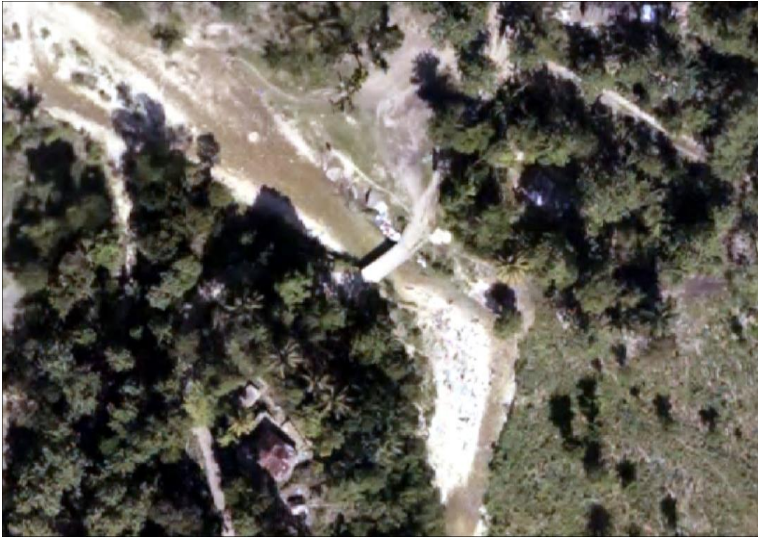
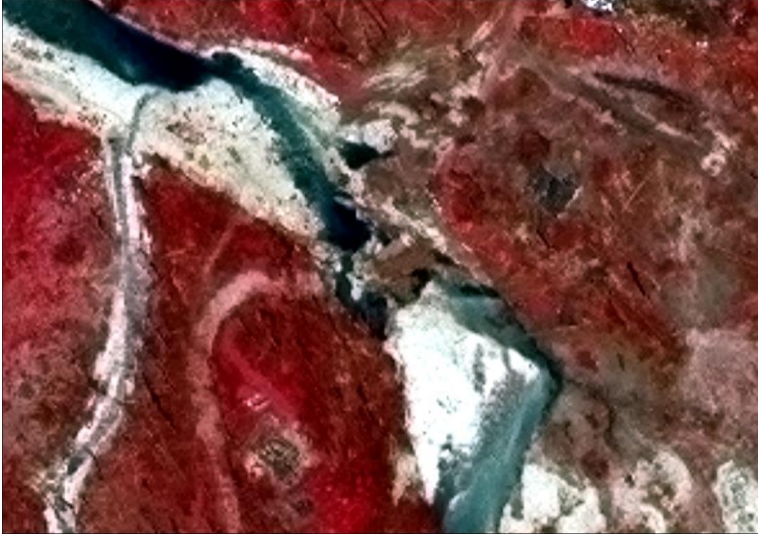
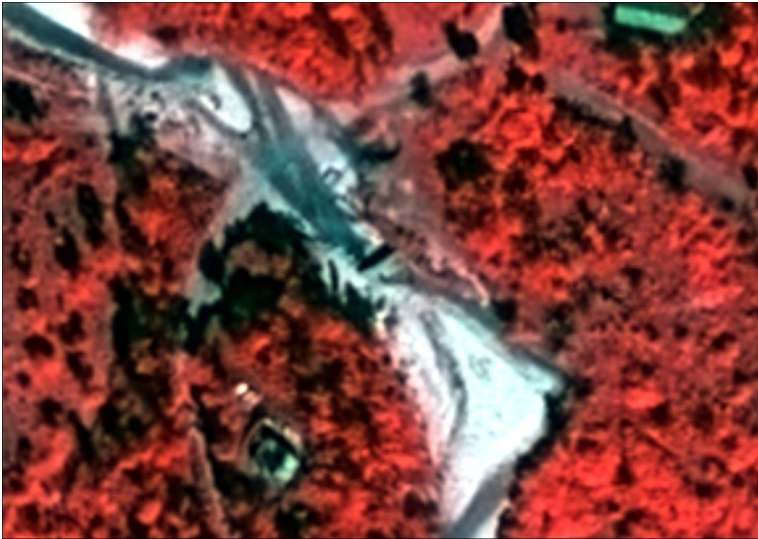
| <i>Time stage</i> | <i>Images</i> | <i>Observations</i> |
|---|--|---|
| t_1 | | <p>This bridge was removed by the river flood caused by the hurricane in t_1. In t_3 it has been rebuilt.</p> |

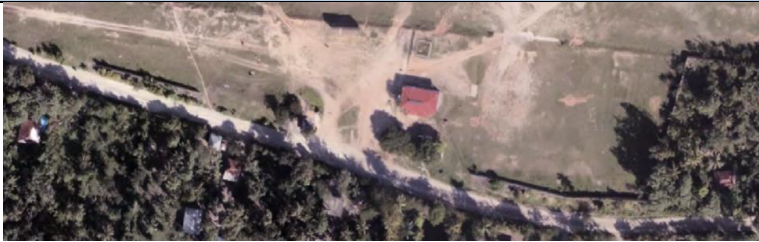
| <i>Time stage</i> | <i>Images</i> | <i>Observations</i> |
|---|---|--|
| t_0 | | <p>Humanitarian help detected soon after the event (Jérémie Airport).</p> <p>Such help was not identified after one year of the event.</p> |

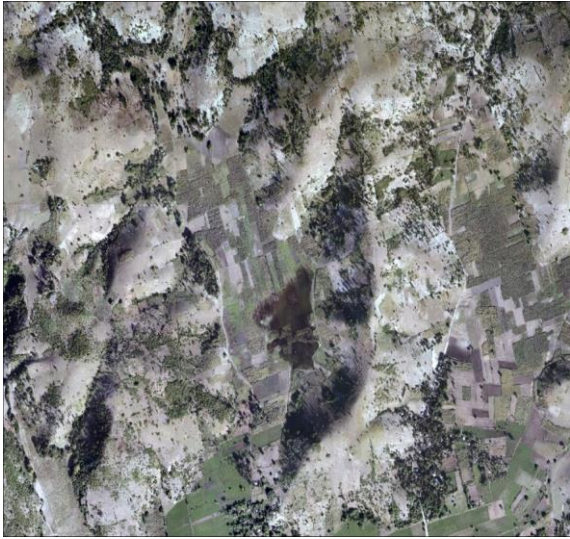
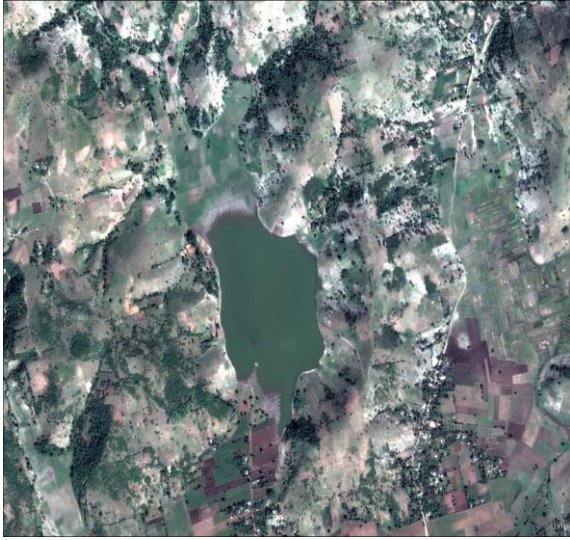
| Time stage | Images | Observations |
|---|--|---|
| t_1 | | <p>An extensive arable land is shown in t_0 boxed between high elevations, this concave area is flooded in t_1 creating a huge lake while in the previous image there was little presence of water; in t_3 part of the lake has retreated fifty per cent of the t_1 surface, where the north arable fields are visible again.</p> |

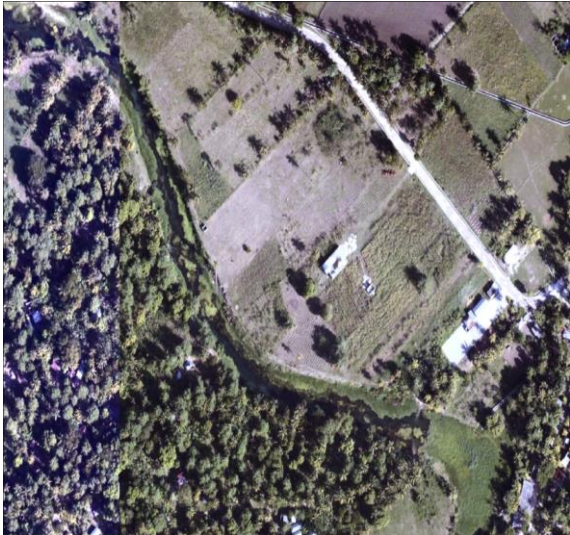
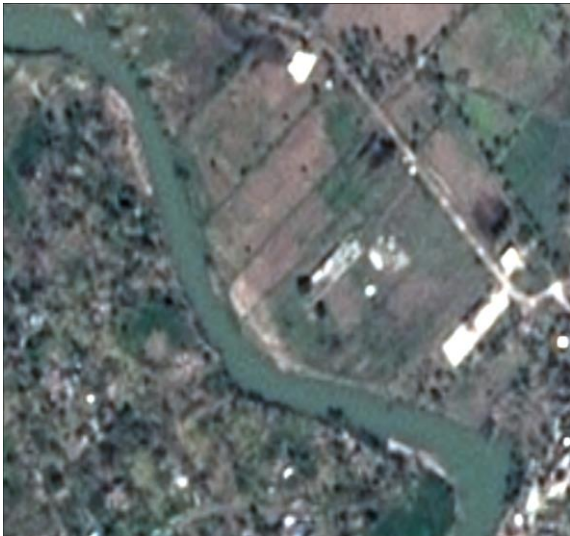
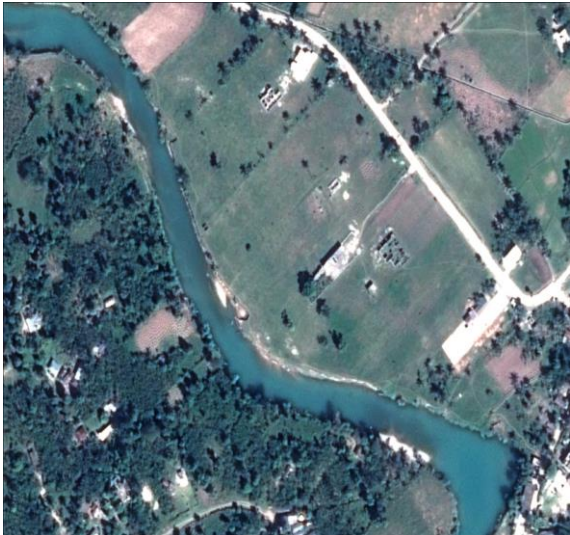
| <i>Time stage</i> | <i>Images</i> | <i>Observations</i> |
|---|--|--|
| <p>t_0</p> | | <p>The most observable differences are in the river course and the tree cover; in t_0 there was a prominent wooded area and a little river width, in t_1 the river course is growing his course width maintaining it in t_3 while the forest has empty spaces and in t_3 the trees has occupied again these clear areas.</p> |

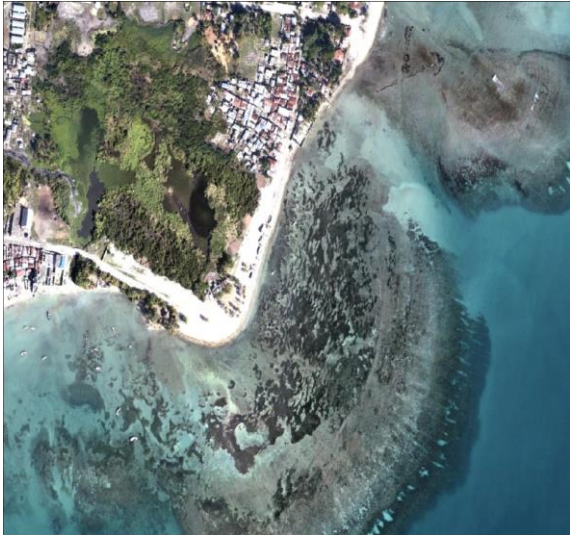
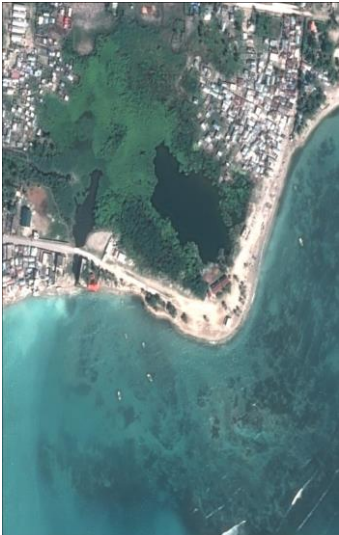
| Time stage | Images | Observations |
|---|--|--|
| <p>t_0</p> <p>t_1</p> <p>t_3</p> | | <p>Focusing in the seafront, in t_0 we can observe the buildings and roads are in use, in t_1 the storm has destroyed the road accesses and part of the seafront corner and their houses; it has been recovered in t_3, specially the left access road and the buildings on them.</p> |

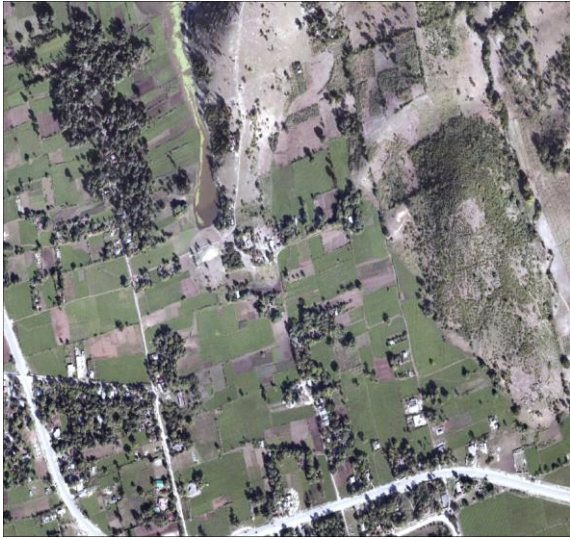
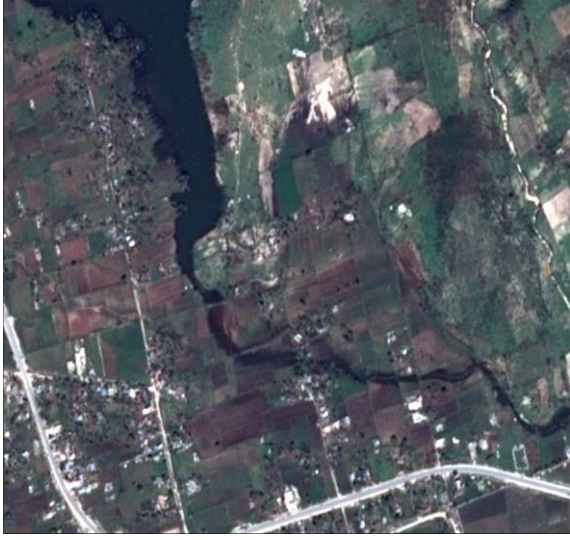
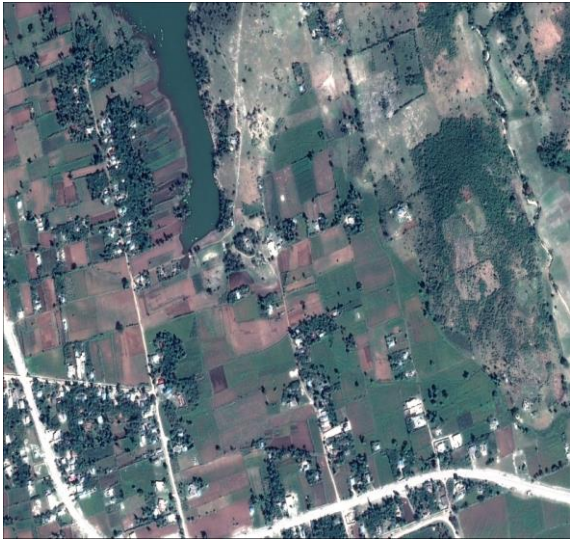
| <i>Time stage</i> | <i>Images</i> | <i>Observations</i> |
|---|--|---|
| t_1 | | <p>In the north part of the t_0 image there is only a little water area surface, this portion increase his size in t_1 communicating with the lake at the north and creating a new river course running to the SE, in t_3 it maintains the lake connection in the north but the water line in the SE is disappeared.</p> |
